# STRUCTURAL FIRE ENGINEERING

## INVESTIGATION OF BROADGATE PHASE 8 FIRE

#### EXECUTIVE SUMMARY

On the 23rd June, 1990 a fire developed in the partly completed fourteen storey building in the Broadgate development.

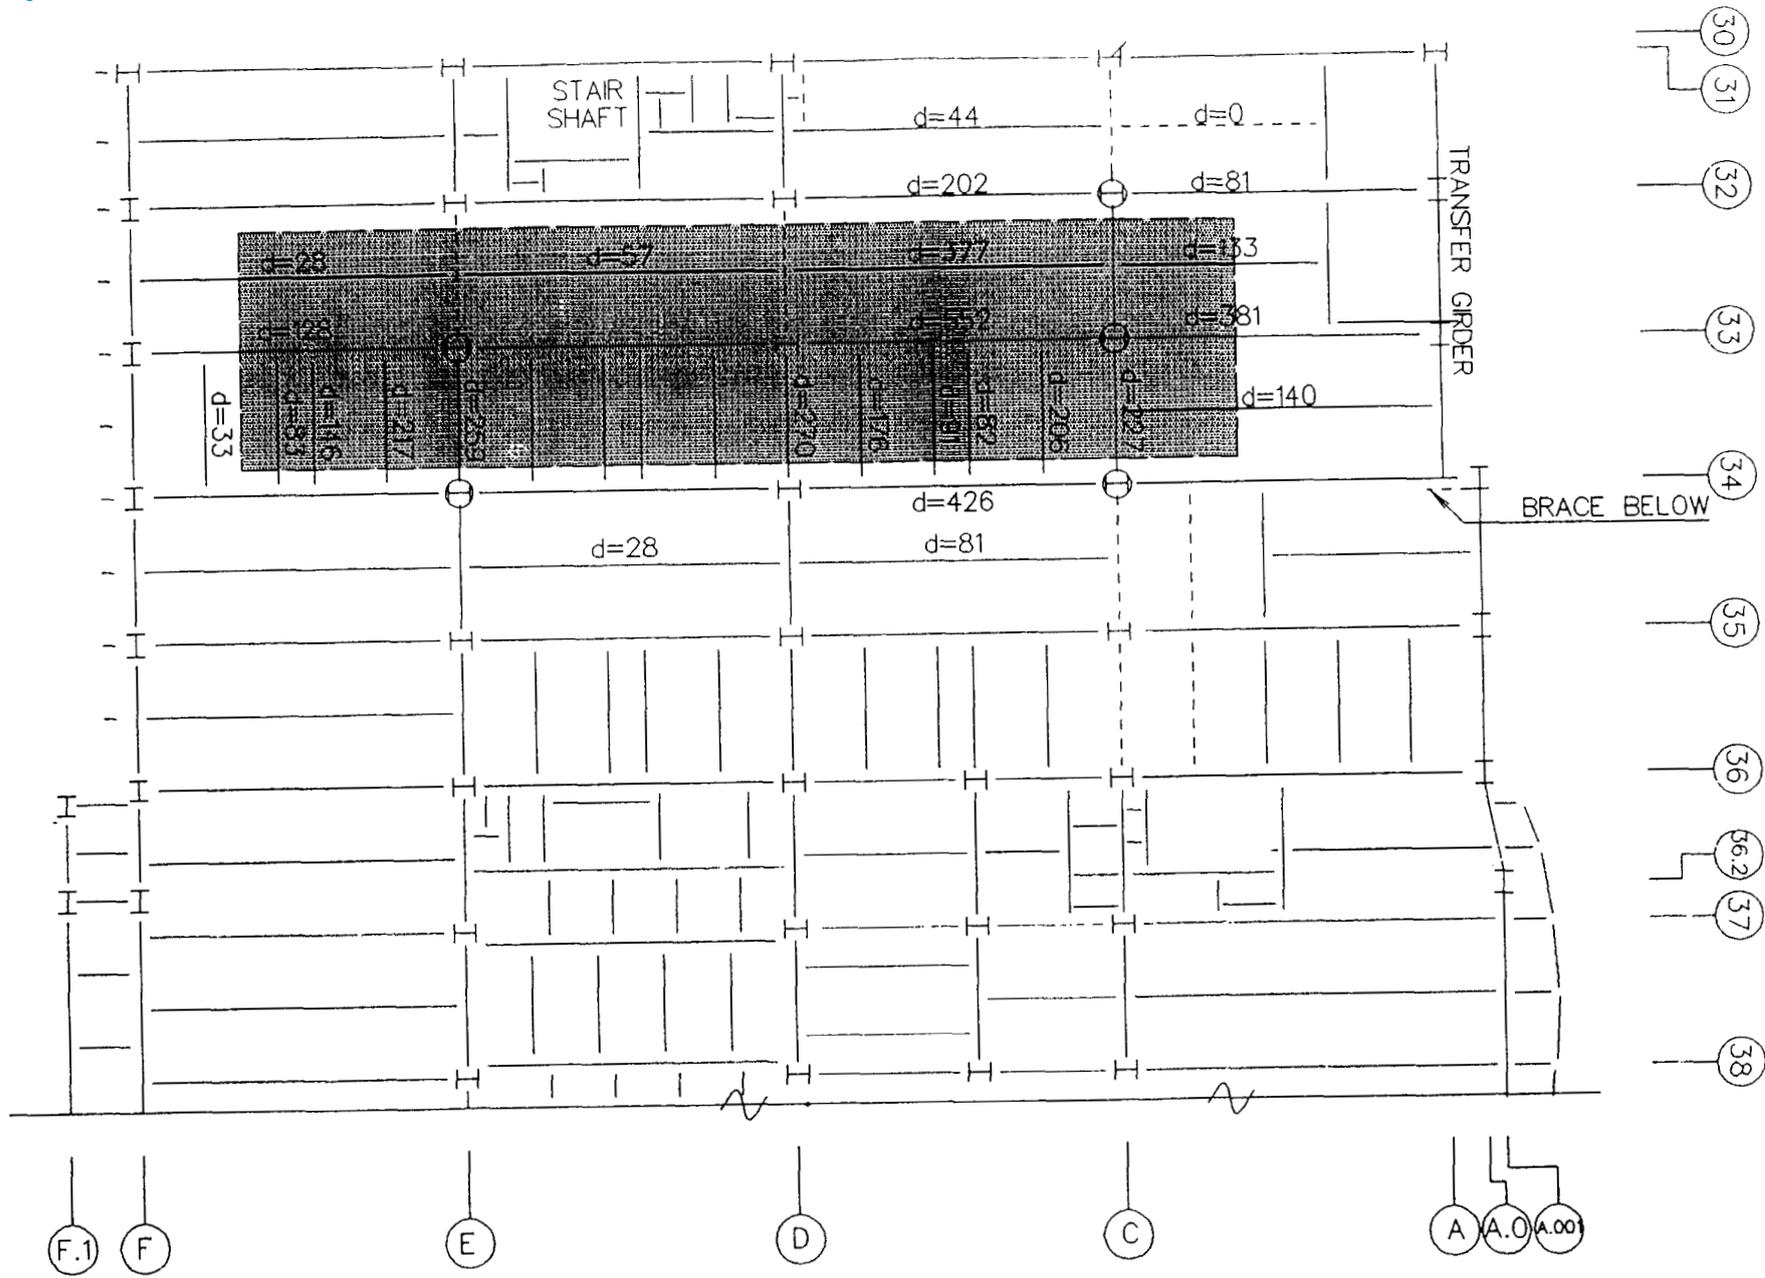
The damage to beams included overall bowing which was fairly even along the length, sagging over only part of the length, local buckling at the ends along the bottom flange and in some cases web lateral distortion. There was no clear evidence of the formation of midspan plastic hinges.

Figure 7: Plan Level 2 showing beam deflection relative to end of that member

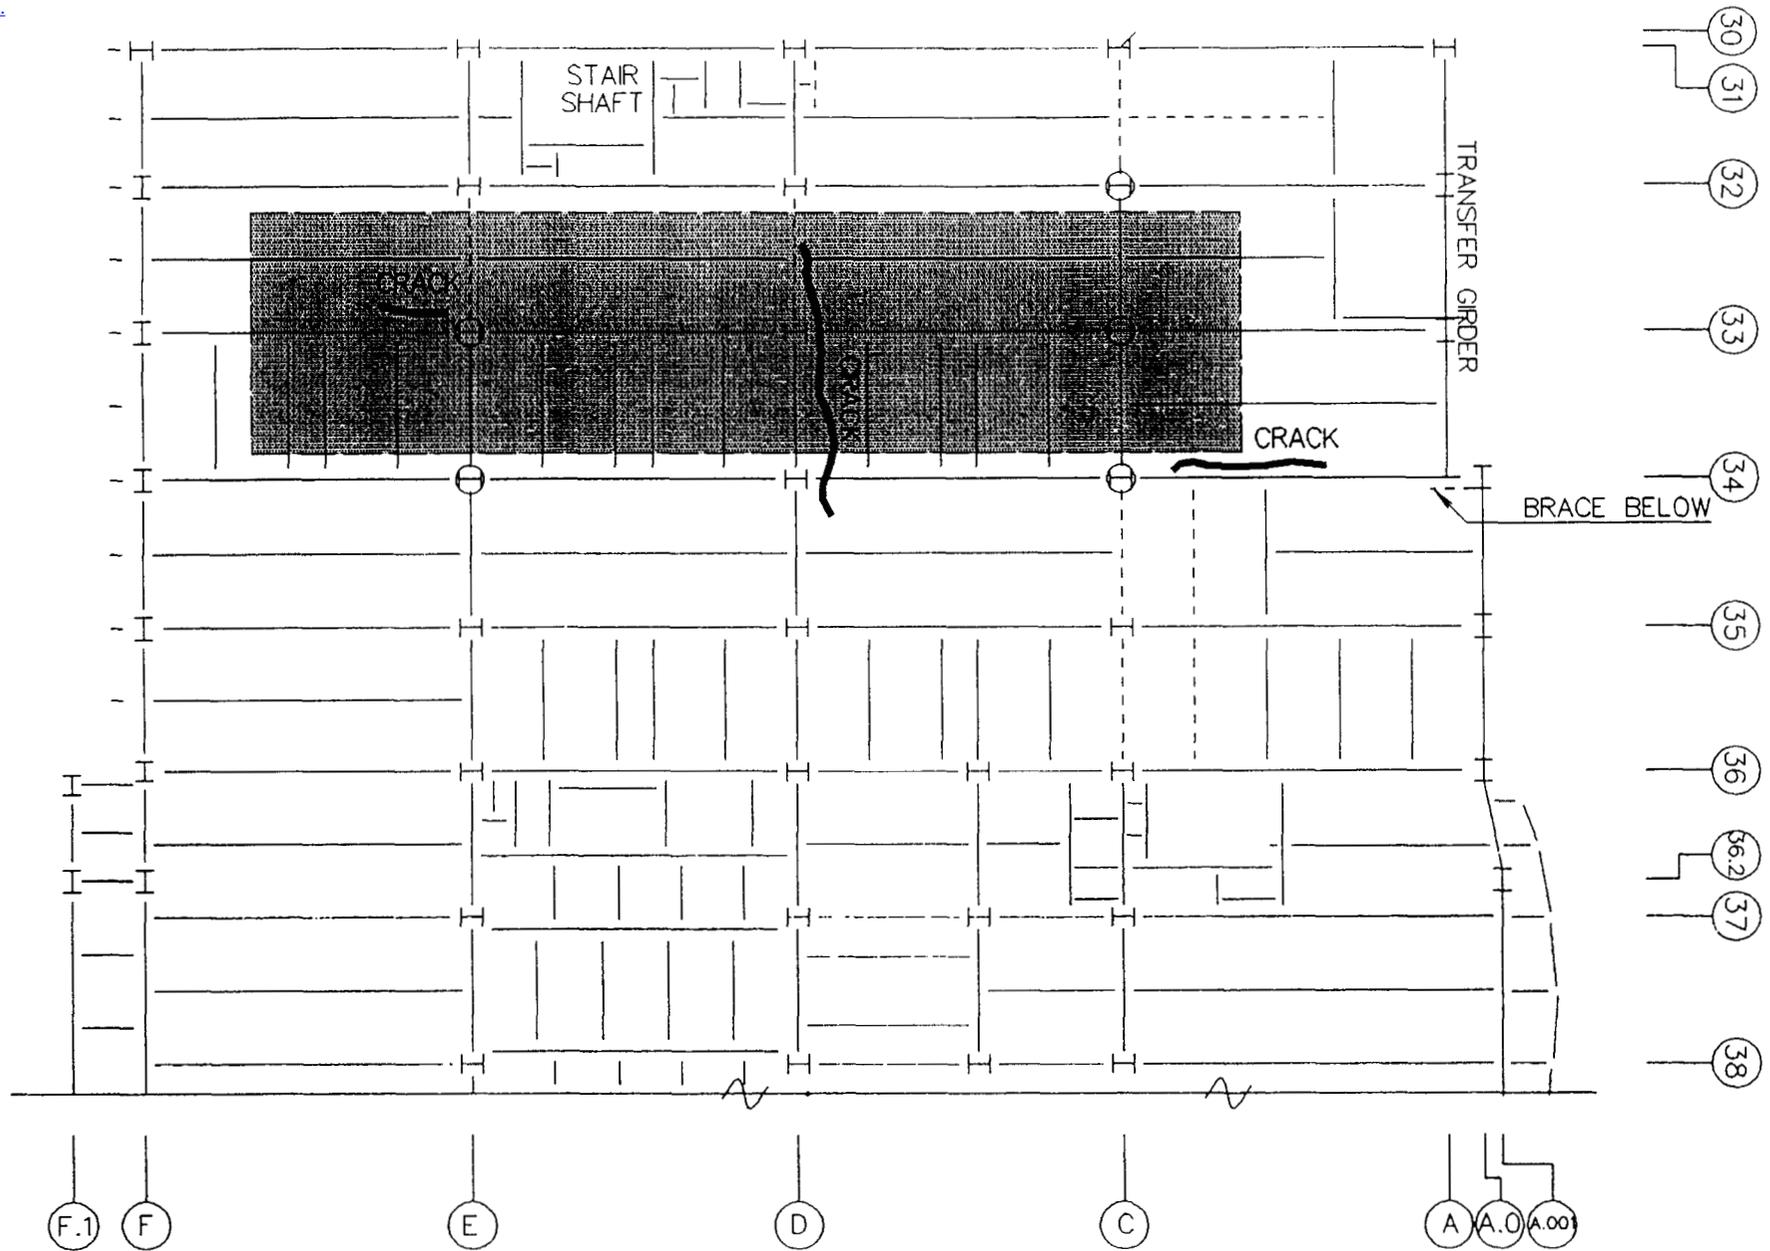
The floor slab suffered debonding of the steel deck in all areas of the fire zone. The deformation of the concrete generally followed that of the supporting members below with further deflection of the slab between these supporting members (see Table 2). This deflection resulted in horizontal and vertical cracking within the concrete. The vertical cracks tapered to zero width at the top face. Three large cracks were observed in the floor slab from the top surface of Level Two (see Figure 8). These large cracks resulted in stepped openings where the reinforcement had fractured as a consequence of a ductile failure.

Figure 8: Plan Level 2 showing position of major cracks in concrete floor at Level 2

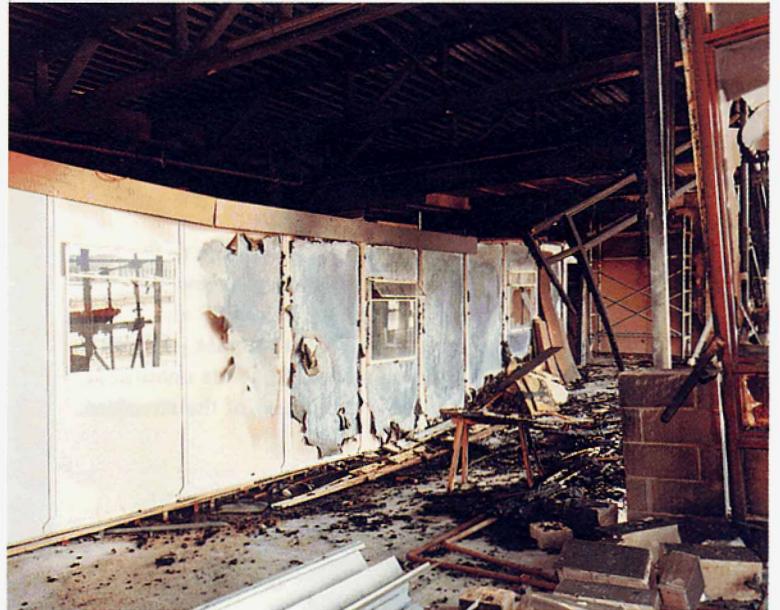
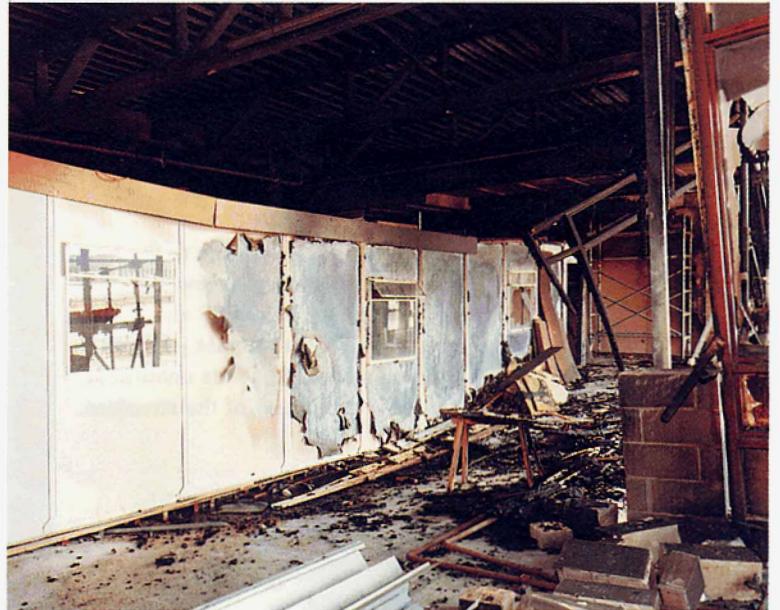
Plate 2: Photograph of a sub-contractor's hut typical of that which was destroyed during the fire. This hut is located at Level Two and was damaged externally during the fire as a consequence of flames through the windows from the fire at the floor below. Note flaking pvc wall coating.

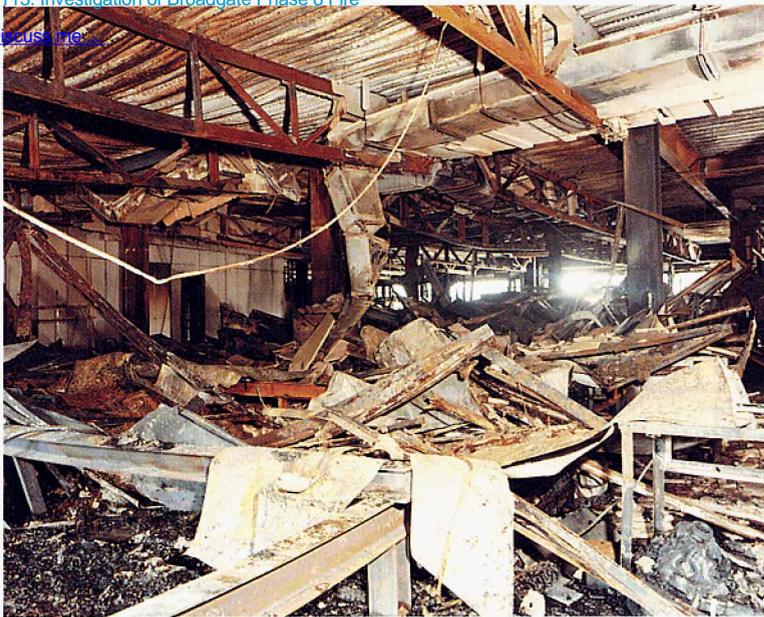
Plate 4: Fire damage to the hut. View towards core and Bishopsgate showing cols. D32, D33 and D34.

- Note:
- a) Numerous deformed sheet steel components from the hut.
  - b) Complete burnout of the hut floor in this area.

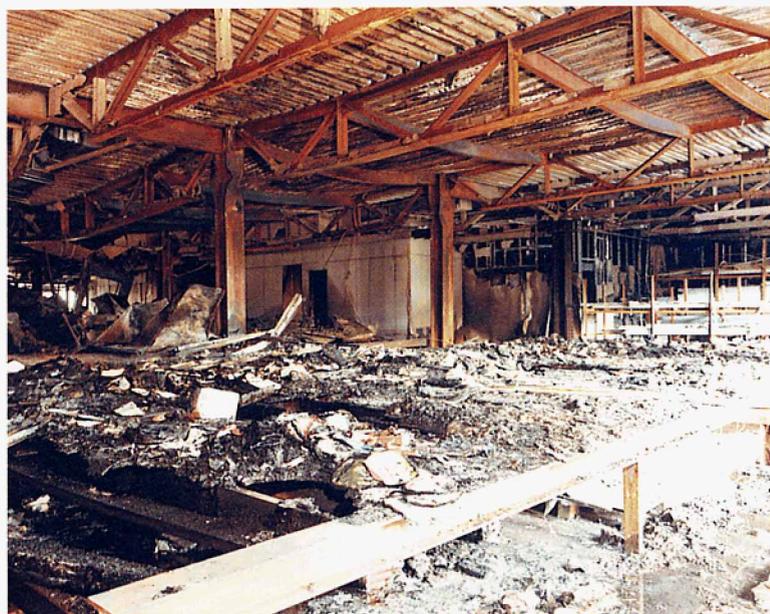
Plate 5: Fire damage to the hut. View from Bishopsgate towards core showing cols. E33 and E34. Note the charred timber joists and the combustible goods unburnt at this end of the structure.

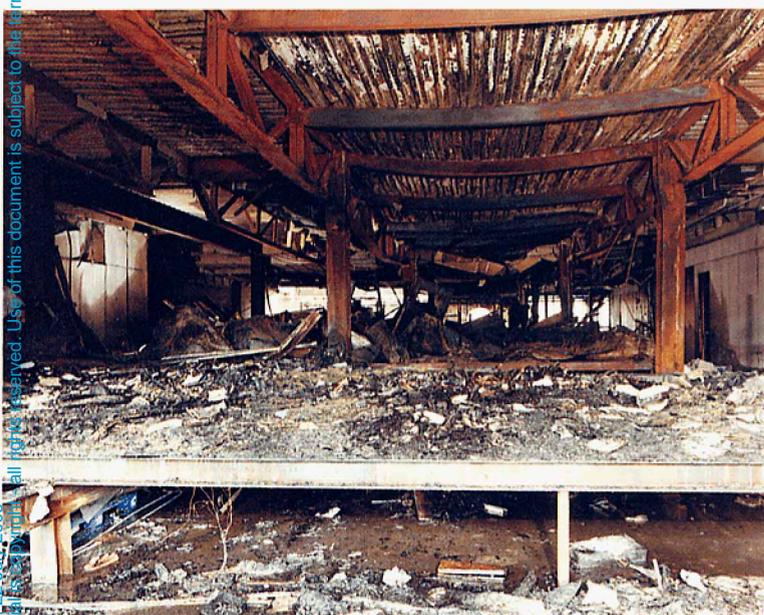
Plate 6: View from Bishopsgate showing cols. E32, E33 and E34. Note unburnt portion of hut floor.

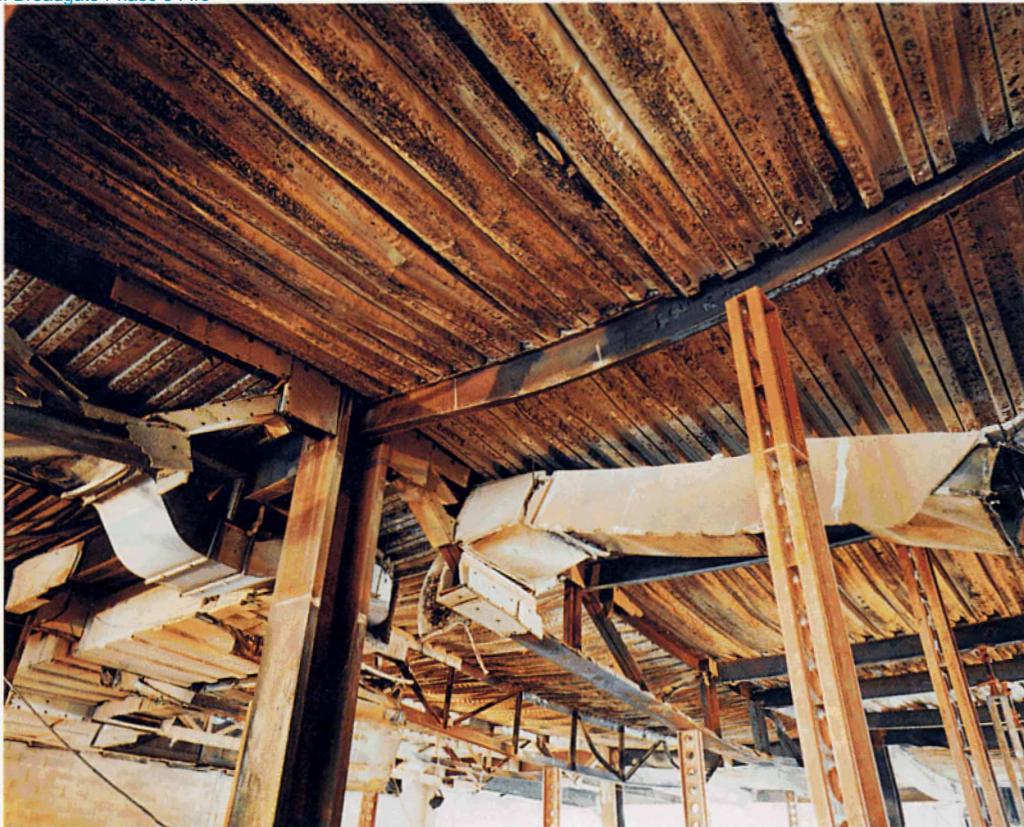
Plate 7: View towards Exchange Square and Phase 7 wall showing damage to the structure.  
Note: a) The undeformed heavy col. D33. b) The deflection of the light beam D3. c) The detachment of the metal deck from the top flange of beam D3. d) The deformation of truss CD5.

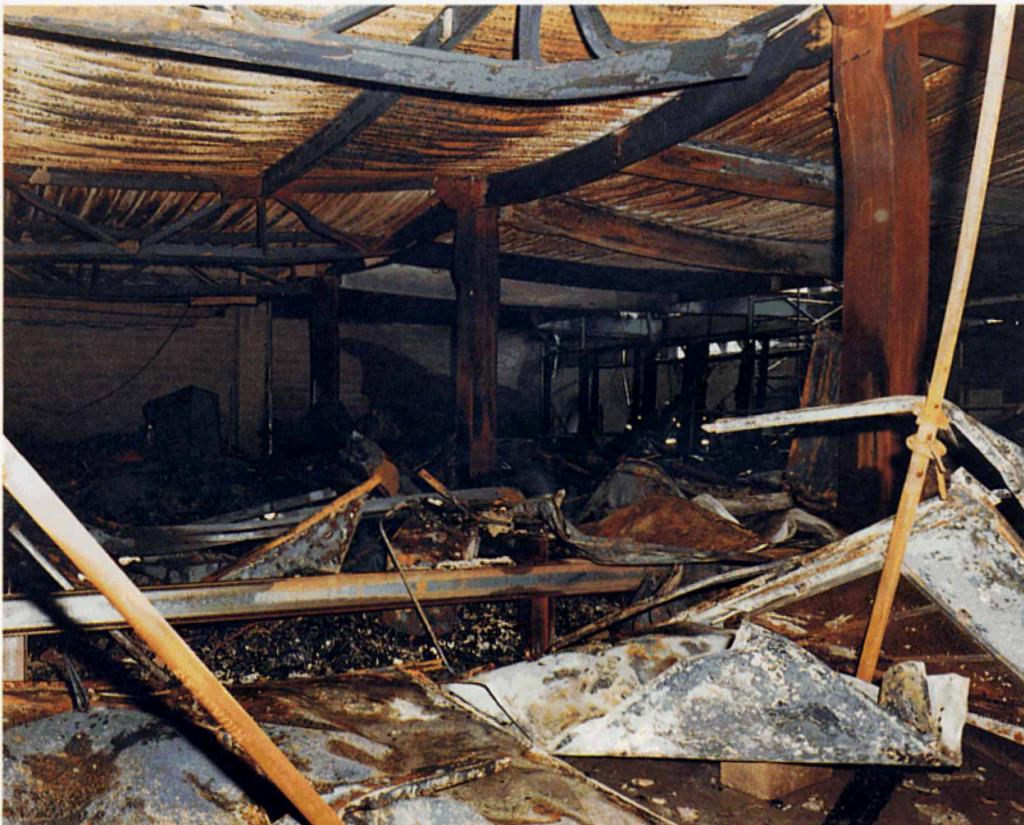
Plate 8: View towards Exchange Square and Phase 7 wall showing deformation of the structure.  
Note: a) The deformed cols. C32, C33 and C34. b) The deformed diagonal bracing members of trusses CD5 and CD6 c) The buckling of the lower flanges of beams AC5 and C3 at the column connections.

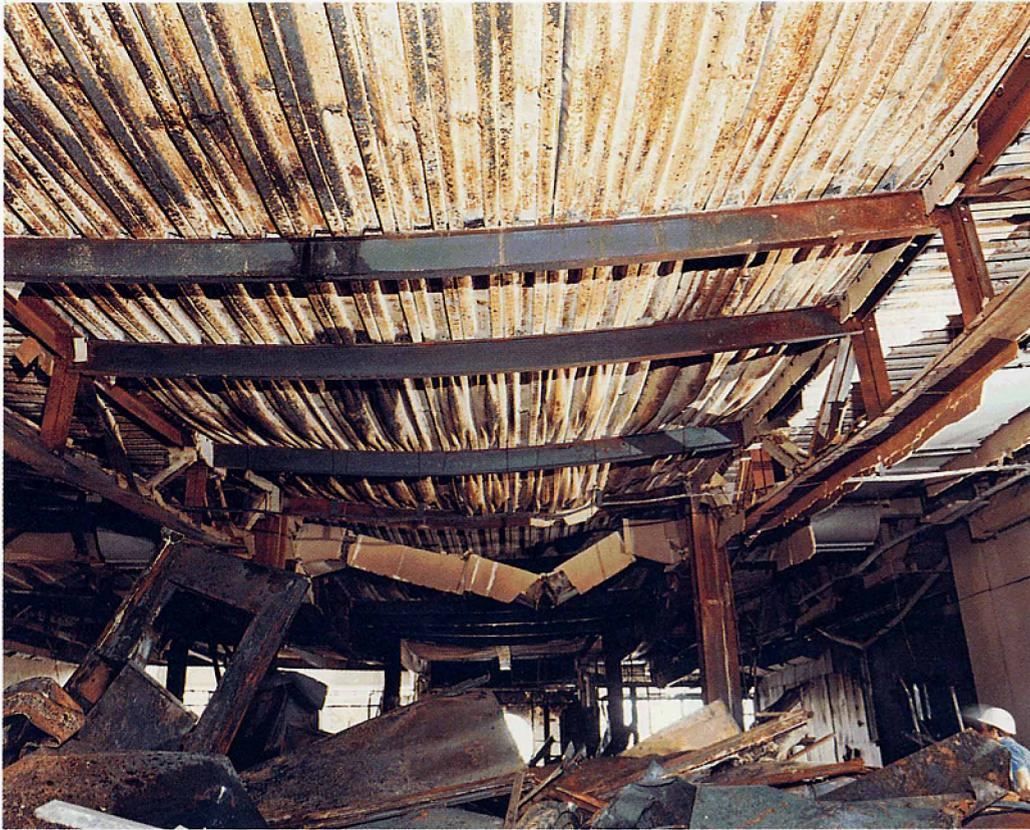
Plate 9: View between lines 33 and 34 facing Exchange Square showing deformation of the structure.

Note: a) The lack of buckling in beams CD20, CD21 and CD22 supported by the truss compared with the buckling and greater deflection of beam C3 framing into the column.  
b) The deformation of the metal deck, i.e. crinkling and ballooning out.

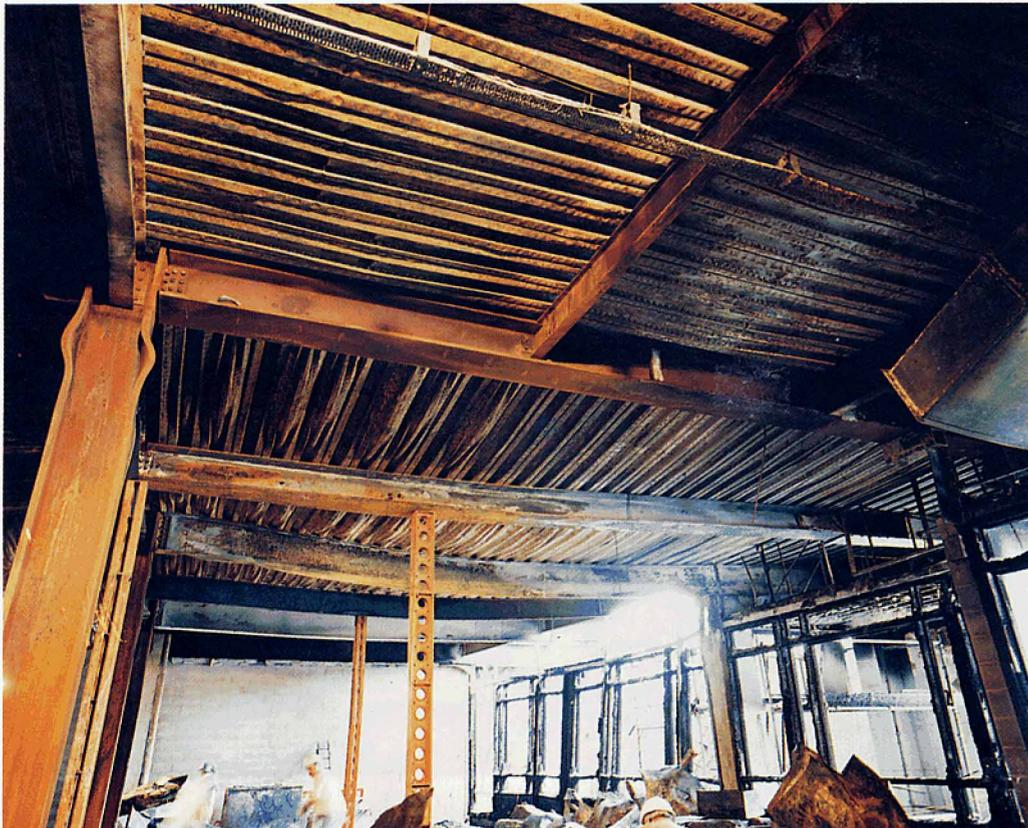
Plate 10: View towards Phase 7 and Exchange Square showing column C34.

Note: a) Buckling of col. C34. b) Buckling of lower flange of beam AC5  
c) Uniform deflection of beams AC6 and AC7.

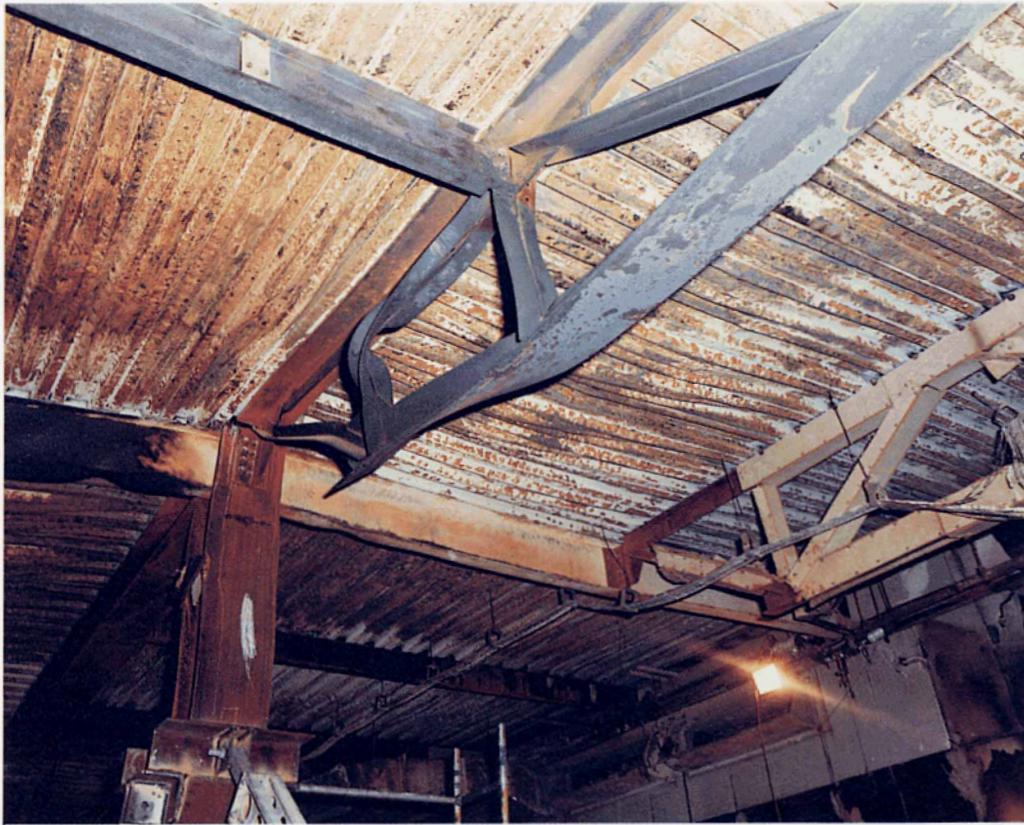
Plate 11: View towards Exchange Square showing column C34.

Note: a) Deformed end of truss CD6 b) Buckled flanges of beams C3 and C4.

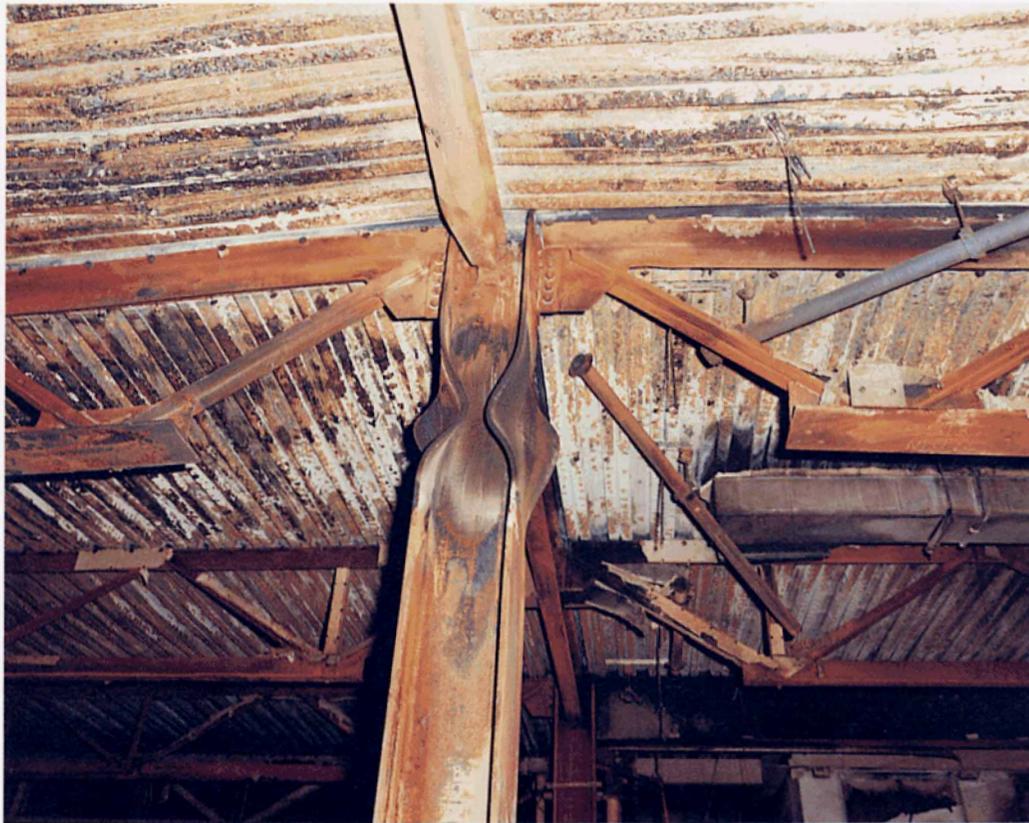
Plate 12: View towards Phase 7 of Column E33

Note: a) Buckling of column b) Buckling on lower flange of beam E3
