# THE BEHAVIOUR OF MULTI-STOREY STEEL FRAMED BUILDINGS IN FIRE

A European Joint  
Research Programme

ISBN 0 900206 50 0

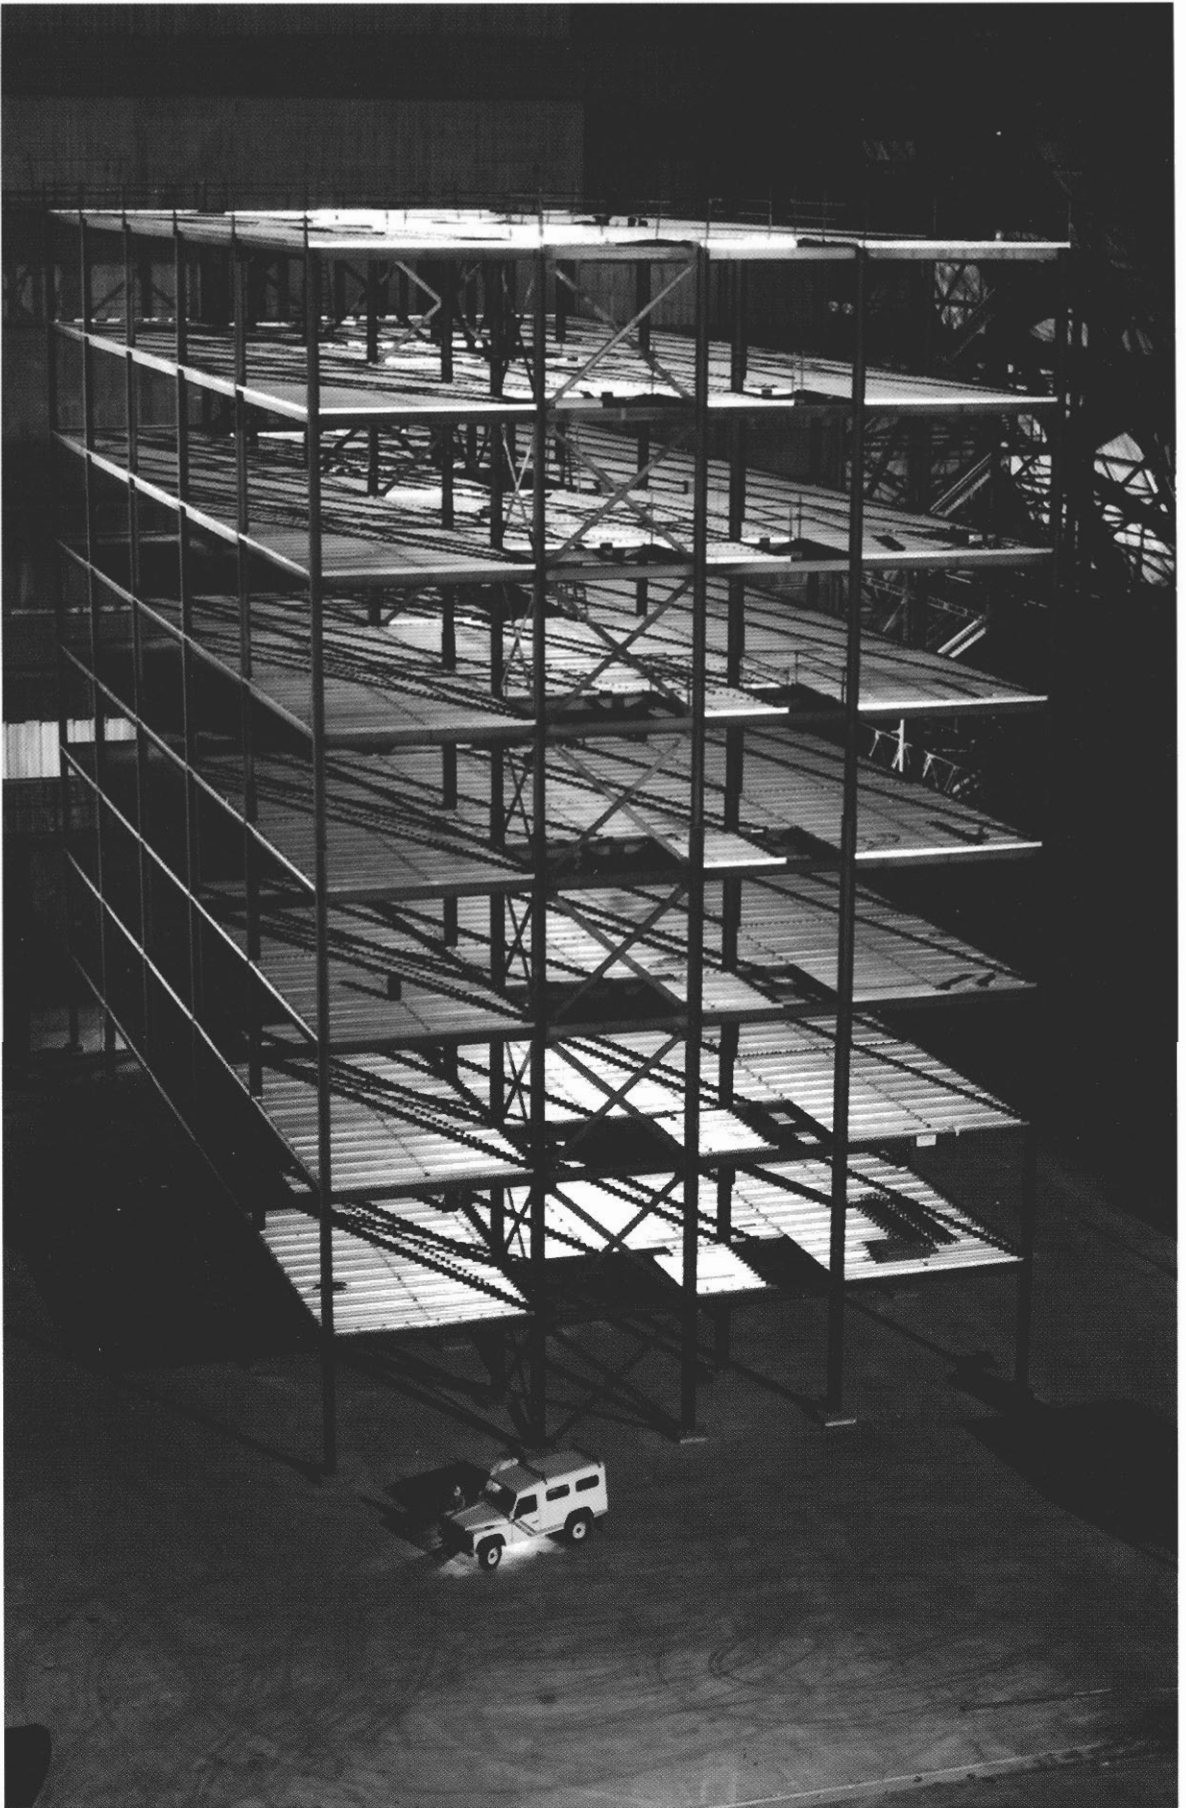
**Figure 1.2** *General view of test structure illustrating the steel frame and steel decking prior to placing concrete and constructing walls.*

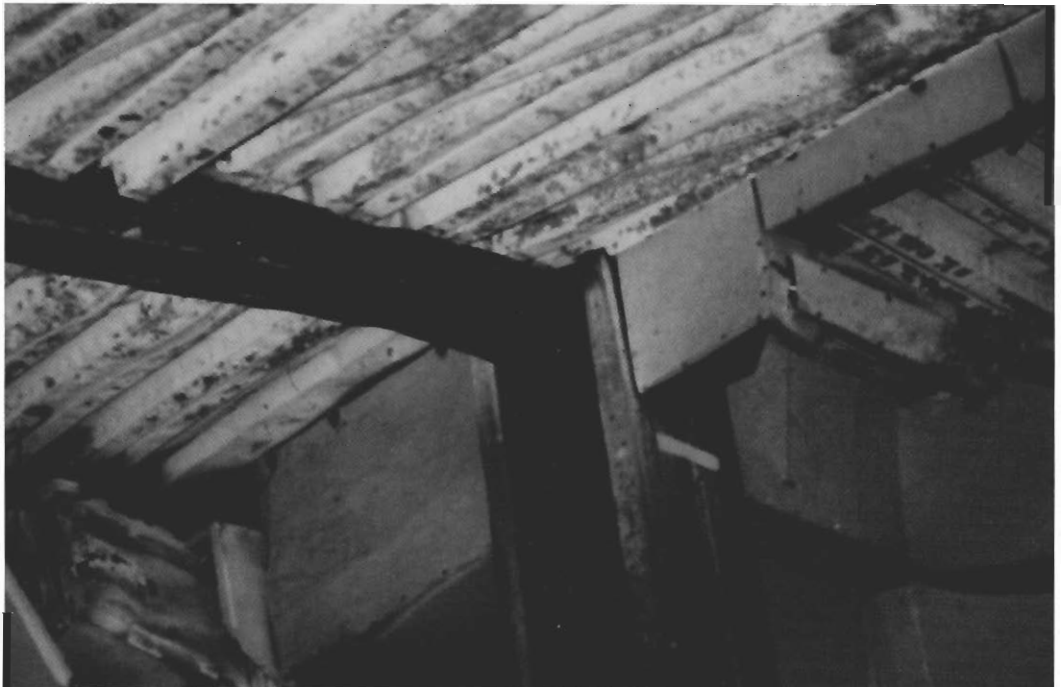
**Figure 2.2** A buckled beam and floor slab at Broadgate following the fire

The fabricated steel trusses supporting the floor slab spanned 13.5m and had a maximum permanent vertical displacement of 552mm, with some components showing buckling deformation. It was concluded that the restraint to thermal expansion provided by other members of the truss, together with differential heating of members, caused additional compressive axial forces which resulted in buckling.

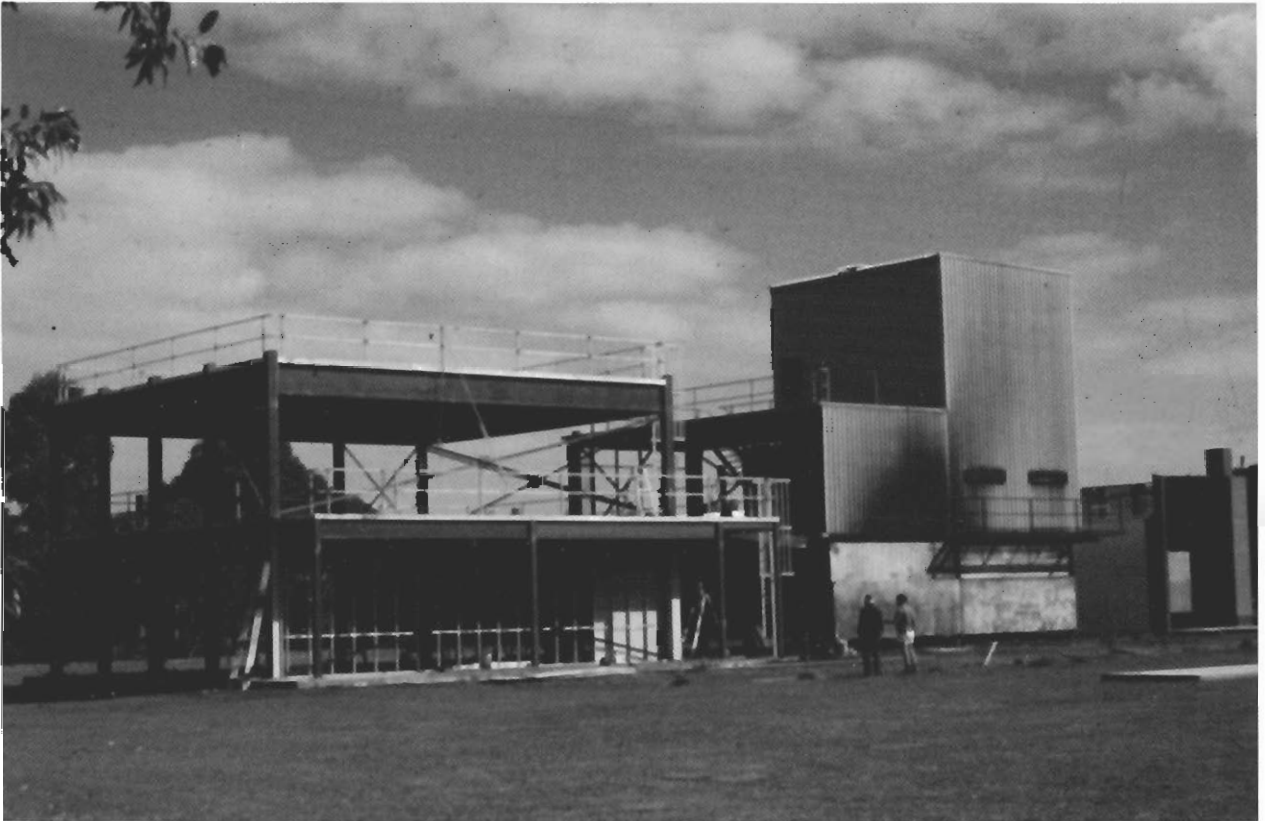
**Figure 3.1** *The BHP test building*

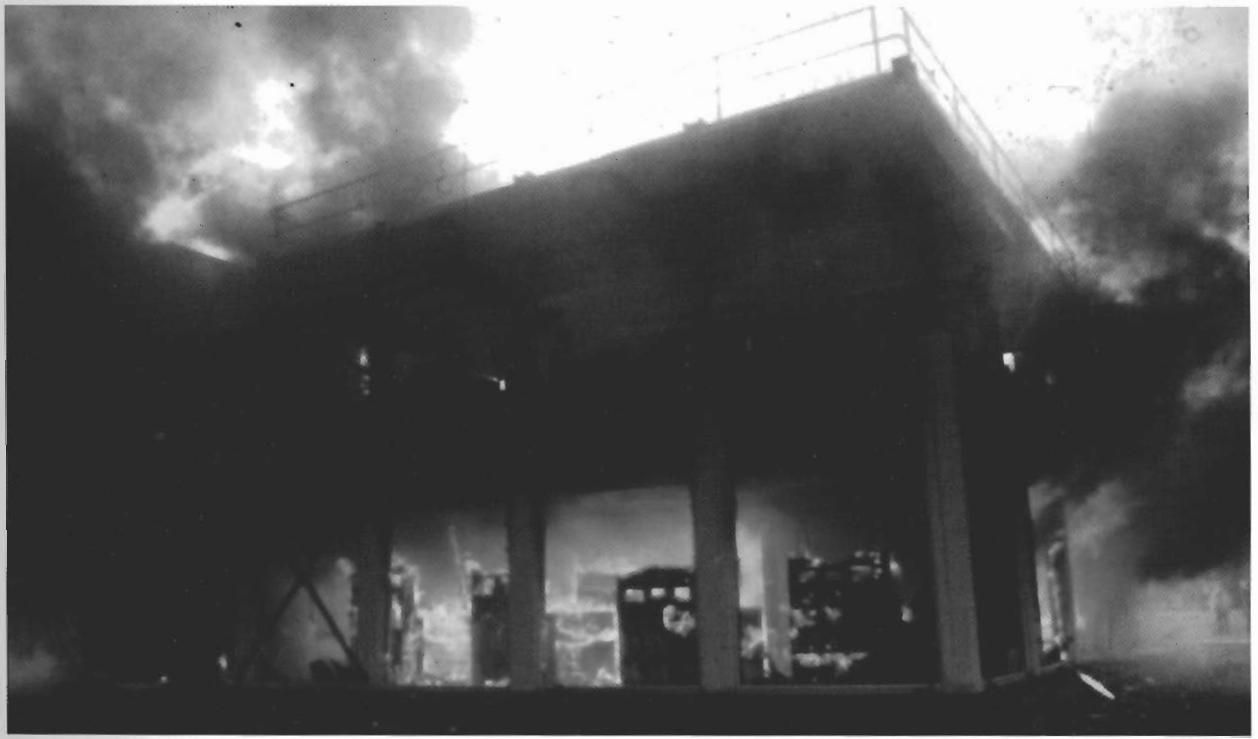
**Figure 3.2** BHP fire test

Following the test it was shown that the non fire rated ceiling system provided an effective fire barrier causing the temperature of the steel beams to remain low. During the test the majority of the suspended ceiling remained in place. Gas temperatures below the ceiling ranged from 831 to 1163°C, with the lower value occurring near to the broken windows. Above the ceiling the air temperatures ranged from 344 to 724°C, with higher temperatures occurring where the ceiling was breached. The maximum steel beam temperature was 430°C.

The internal columns reached a peak temperature of 730°C for the unprotected case and below 400°C for the protected cases. The external columns recorded a peak temperature of 480°C, with the flange nearest to the fire compartment being hotter.

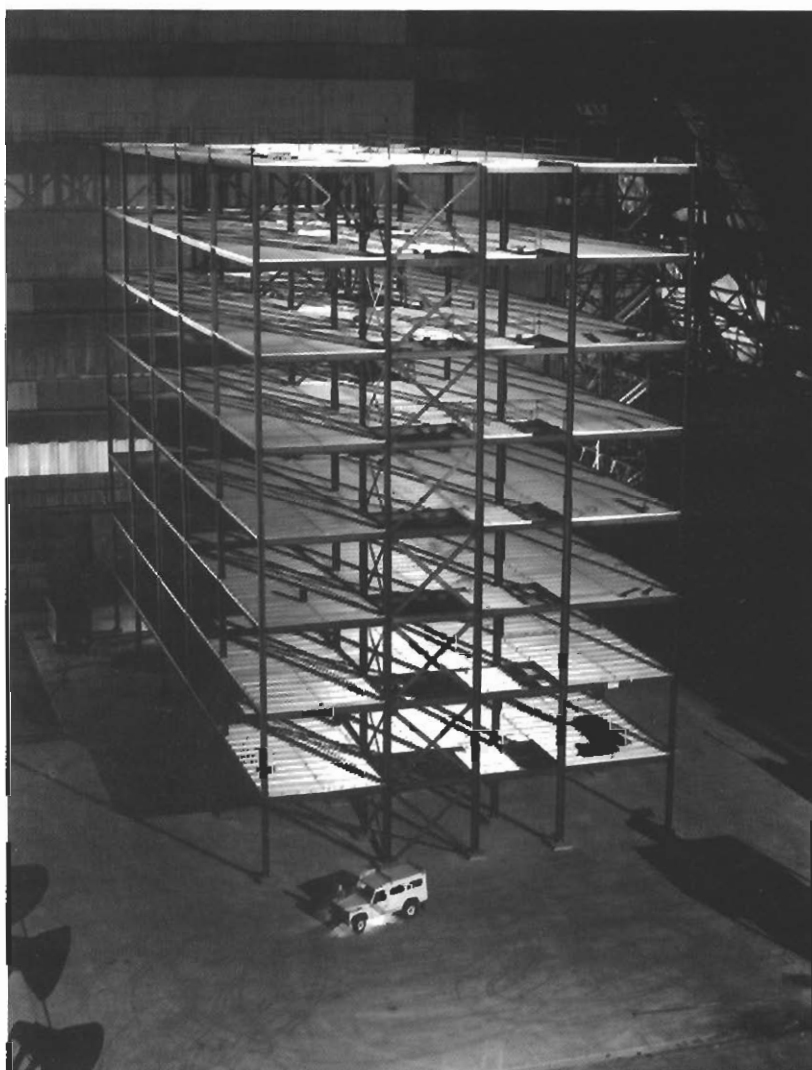
**Figure 5.1** General view of the structural frame

The eight-storey steel-framed test building was constructed by the Building Research Establishment at its Cardington Laboratory near Bedford. The building was designed and constructed to resemble a typical modern city centre office development (Figure 5.1). On plan, the building covered an area of 21m x 45m with an overall height of 33m. There were 5 equally spaced bays along the length of the building. Across the width there were 3 bays spaced 6m, 9m and 6m. Placed centrally was a 9m x 2.5m lift core with two 4m x 4.5m stairwells placed at either end. A central reception area required the removal of two columns in the first two storeys. The columns above this level were supported by transfer beams. A plan of the building is shown in Figure 5.2.

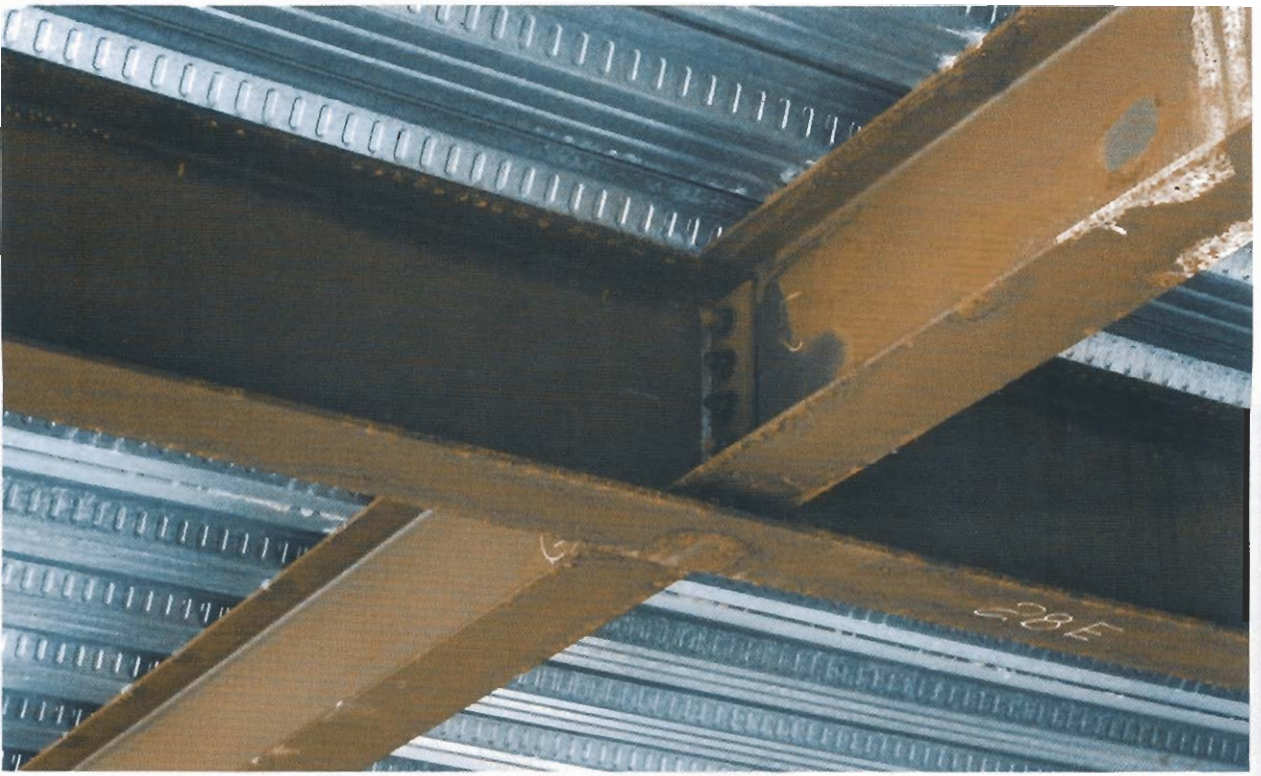
**Figure 5.4** *Fin-plate (beam-to-beam) connection*

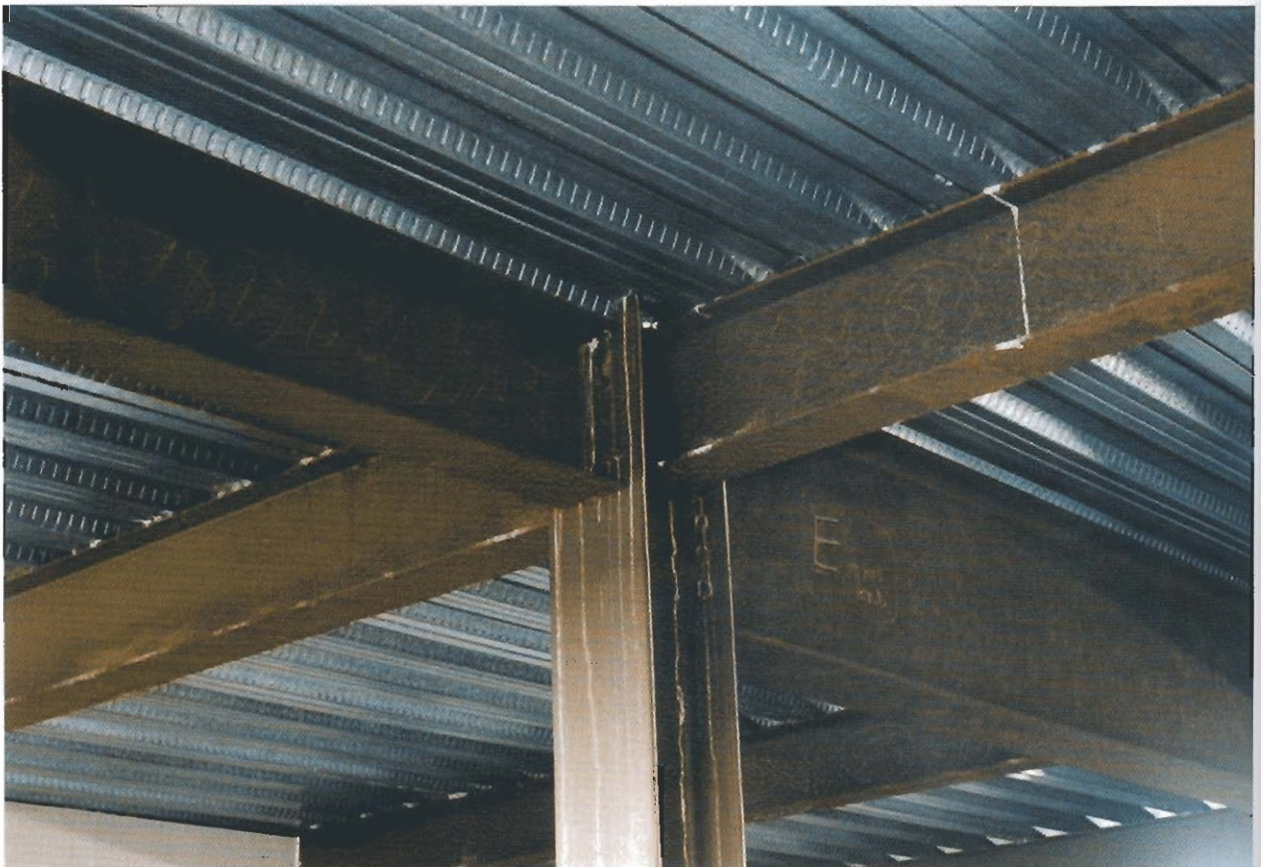
**Figure 5.5** *Flexible end-plate (beam-to-column) connection*

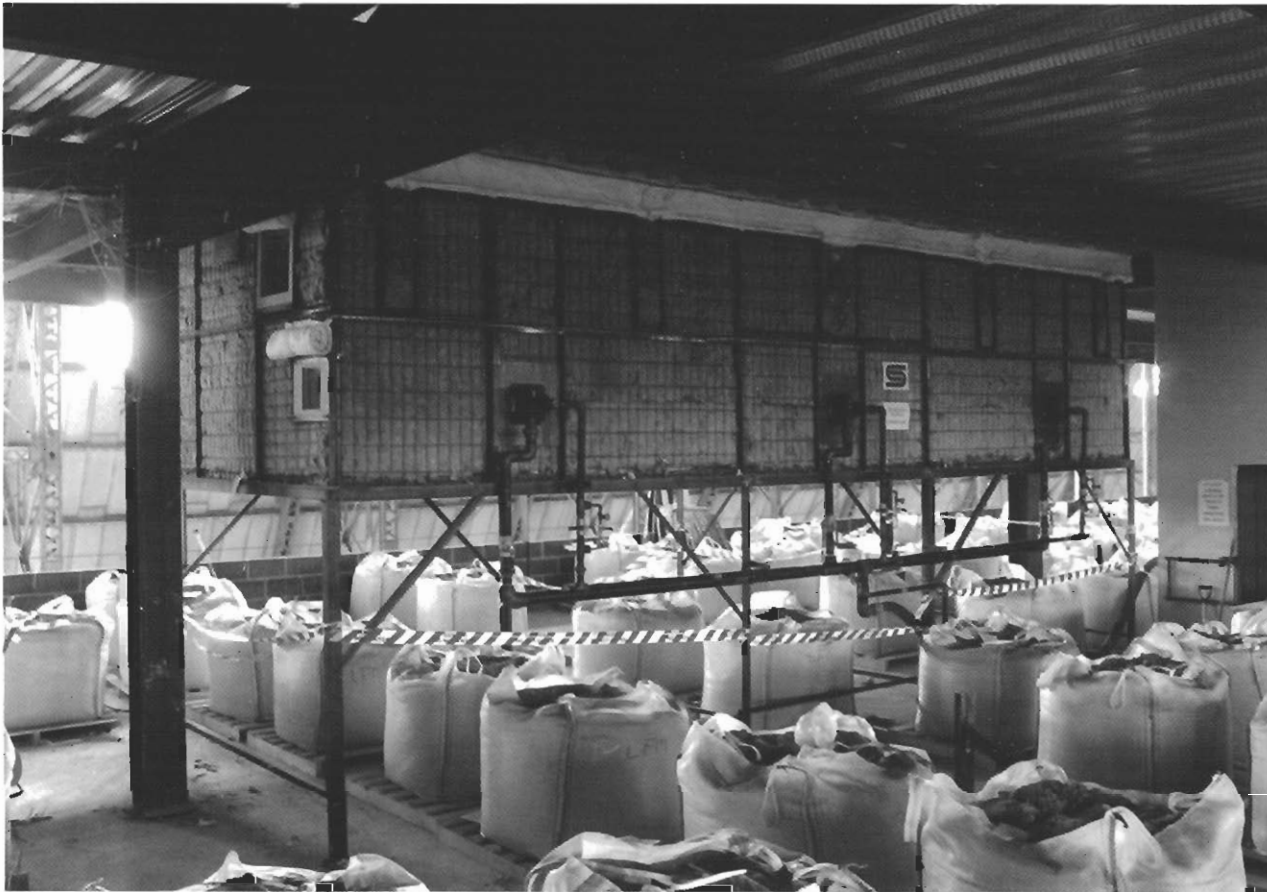
**Figure 6.2** Purpose built gas fired furnace

The restrained beam test was carried out on the steelwork supporting the seventh floor of the building. A purpose built gas fired furnace, 8.0m long and 3.0m wide (Figure 6.2) was designed and constructed (on the sixth floor) to heat a 305x165x40UB, and part of the surrounding structure, spanning between two columns (254x254x89UC). The beam was heated over the middle 8.0m of its 9.0m length, thus keeping the connections as near as possible at ambient temperature.

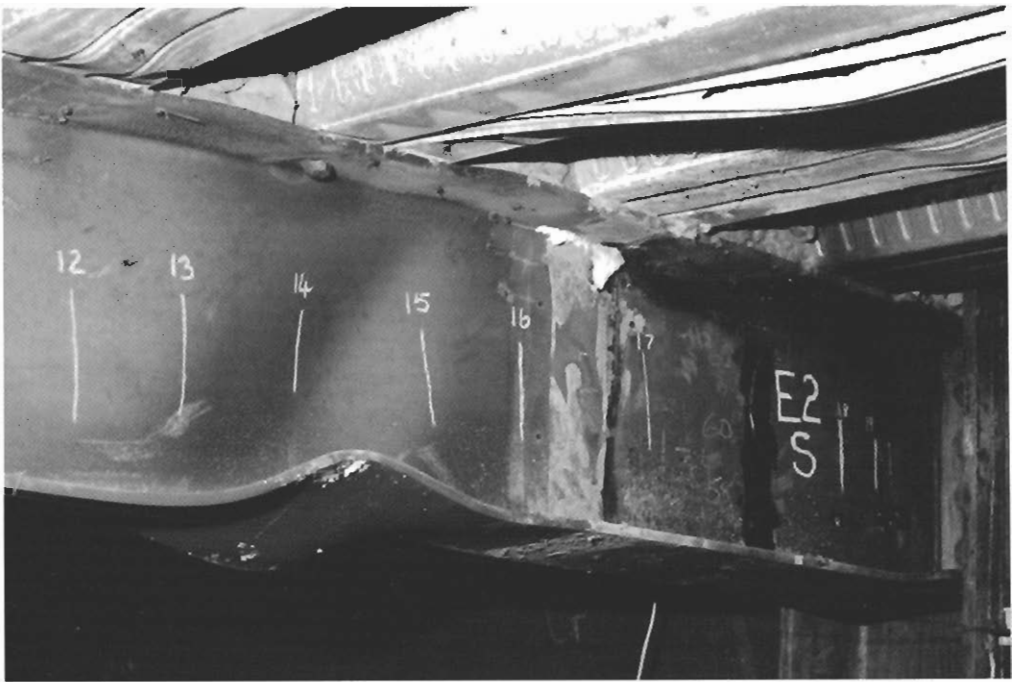
**Figure 6.4** Test 1: Local buckling of test beam just inside furnace

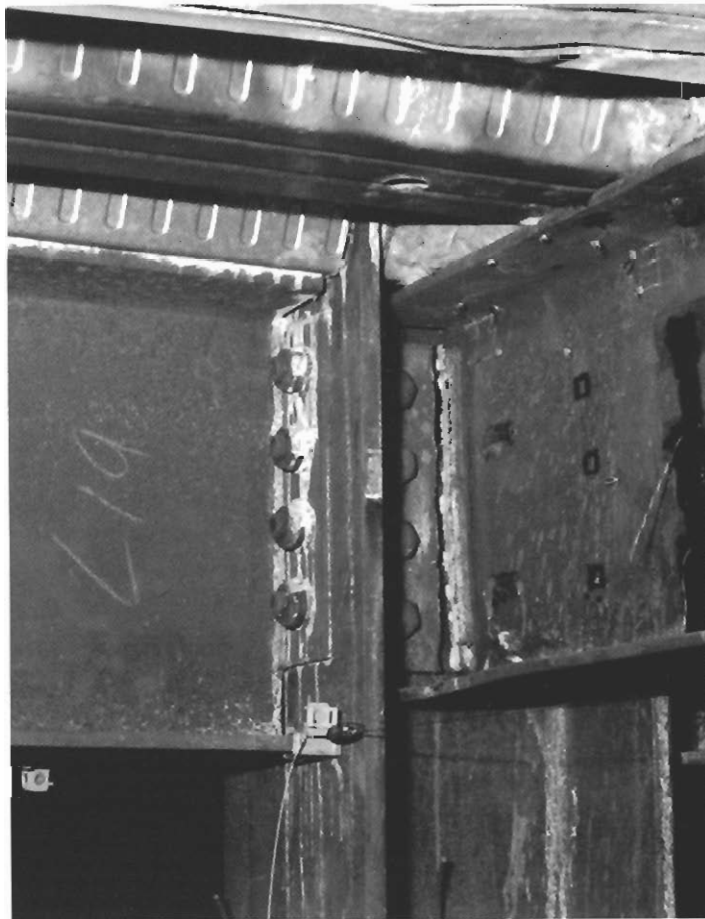
**Figure 6.5** Fractured connection

Visual inspection of the beam after the test showed that the end-plate connection at both ends of the beam had fractured in the region adjacent to the edge of the heat affect zone (Figure 6.5), on one side of the beam. This was caused by thermal contraction of the beam during cooling, generating very high tensile forces. Although the plate has sheared down one side, this mechanism relieves the induced tensile strains, with the plate on the other side of the beam retaining its integrity and thus providing shear capacity to the beam. The fracturing of the plate can be identified from the strain gauge readings, which show that during cooling the fracture process occurred over a period of time rather than instantaneous rupture.

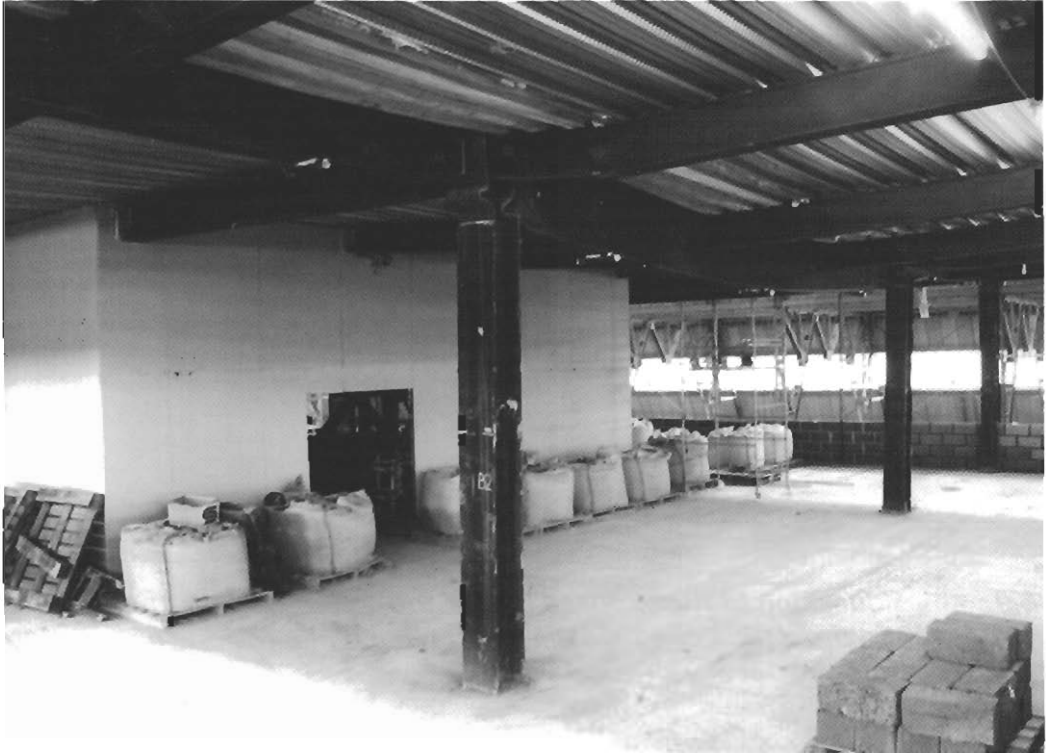
**Figure 6.11**      *General view of the frame following the test*

A general view of the frame following the fire is shown in Figure 6.11, which clearly shows the localised squashing of the column. This behaviour resulted in all the floors above the fire compartment falling by approximately 180mm. In a real building this will cause the floors above the fire compartment, together with the compartment area itself, to be unusable until the damaged structure is reinstated. This would, of course, result in considerable disruption and consequential financial losses for the occupants of the building. Therefore, since the aim is to localise damage to the compartment area only, this test indicates that the columns need to be protected over their full length. This was done in all the following tests.

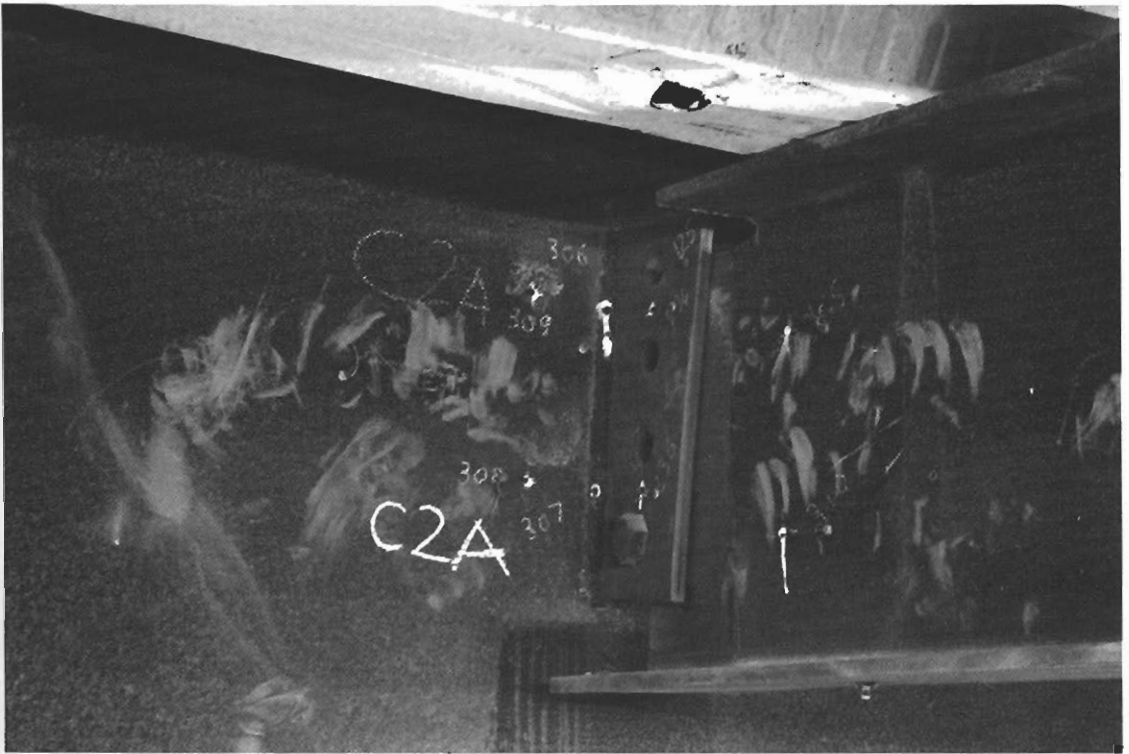
**Figure 6.12** Bolt shear in beam-to-beam connections (fin-plates)

The secondary beams were heated over a length of approximately 1.0m on both sides of the primary beams. After the test, investigation showed that many of the bolts in the fin-plate connections had sheared (Figure 6.12). However, since secondary beams were connected both sides of the primary beams, the bolts had only sheared in the connection on one side of the primary beam. In a similar manner to the fracturing of the plate in Test 1, the bolts sheared due to thermal contraction of the beam section during cooling. The thermal contraction generated very high tensile forces which were relieved once the bolts sheared in the fin-plate on one side of the primary beam.

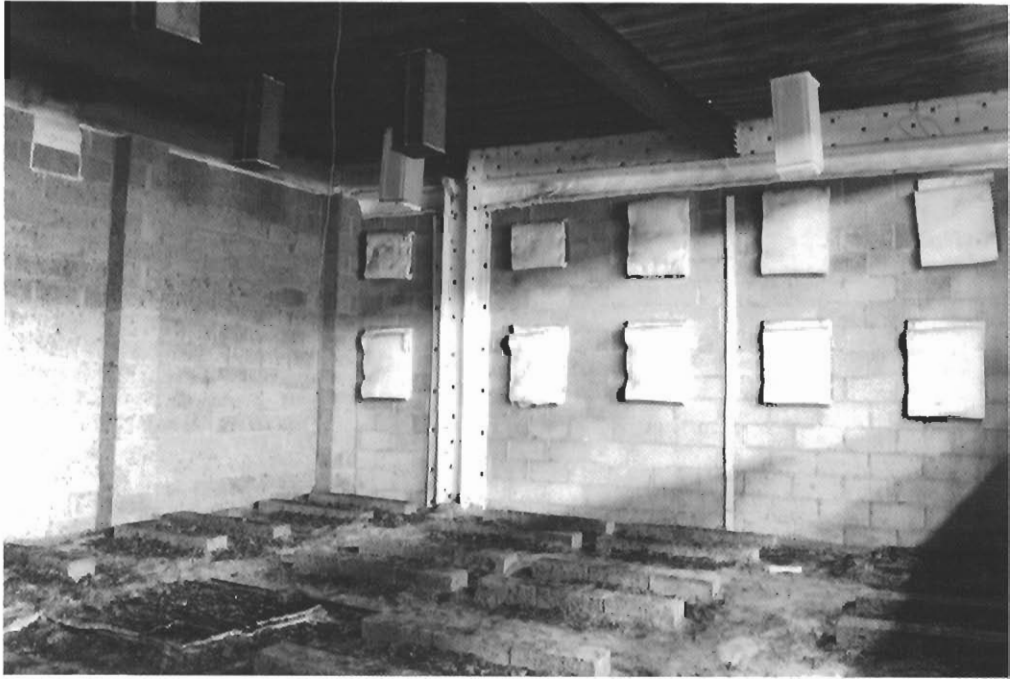
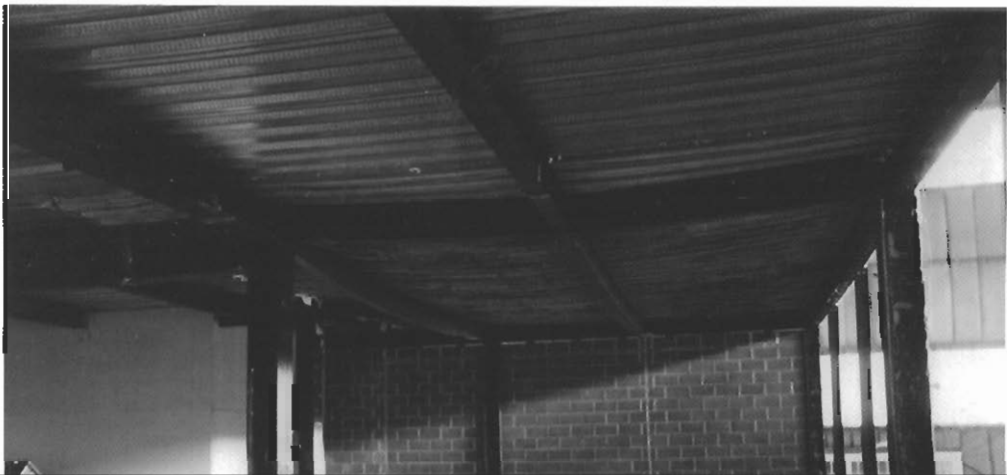
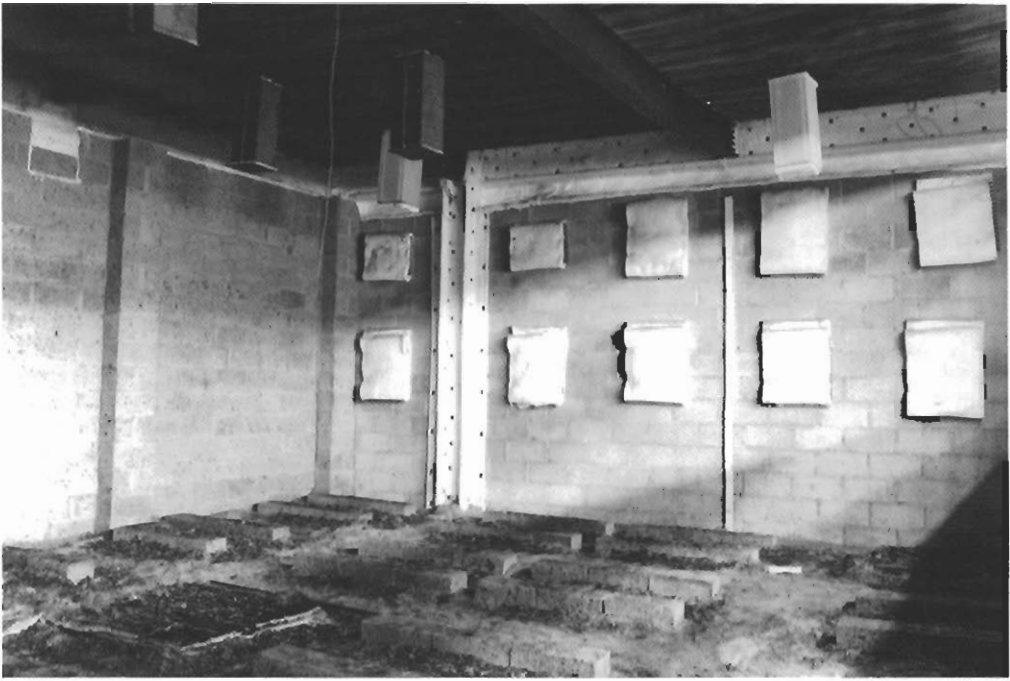
**Figure 6.18** *Internal view of compartment (looking towards gable wall) following the test*

All of the combustible material within the compartment was consumed by the fire, as shown in Figure 6.18. Overall the structure behaved extremely well with no signs of collapse. Figure 6.19 shows the deformation of the structure once the furnace was removed.

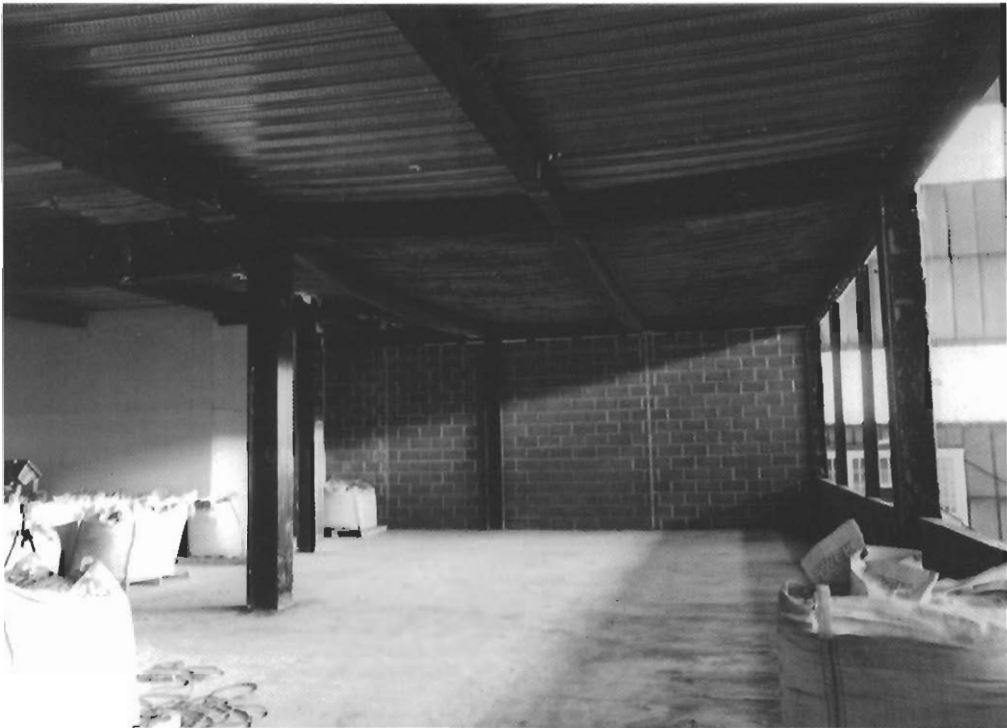
**Figure 6.19** *Structural deformation following the fire*

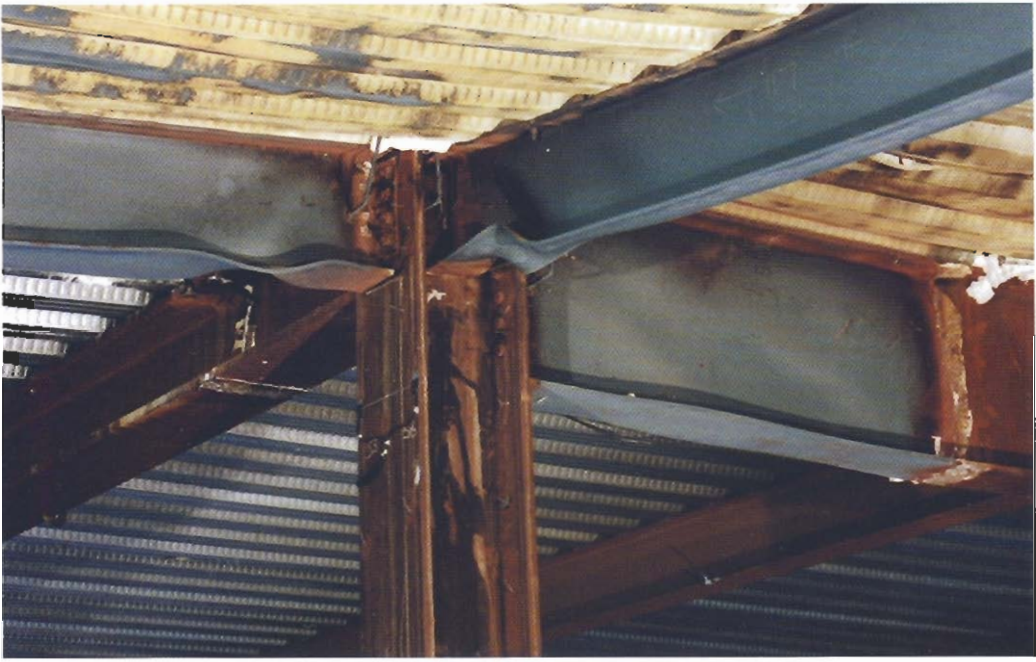
**Figure 6.20** Extensive local buckling occurred in the proximity of the beam to column connections

Extensive buckling occurred in the proximity of the beam to column connections (Figure 6.20). It was of interest to note the behaviour of the fin-plate connection of the internal 9.0m secondary beam. Local buckling occurred at the beams's end which was connected to the primary beam on grid-line E (Figure 6.21). This was caused by axial restraint from the connecting steel members and composite slab. At the other end of the beam which was connected to an external beam, no local buckling occurred (Figure 6.22). This was due to the thermal expansion, of the secondary beam, causing the external beam to twist, thus

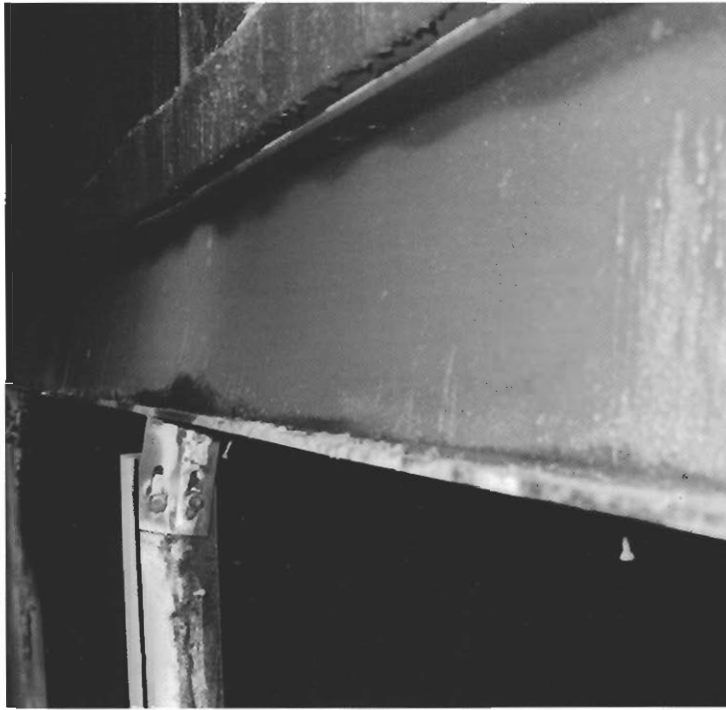
**Figure 6.22** *Twisting of external beam to external beam*

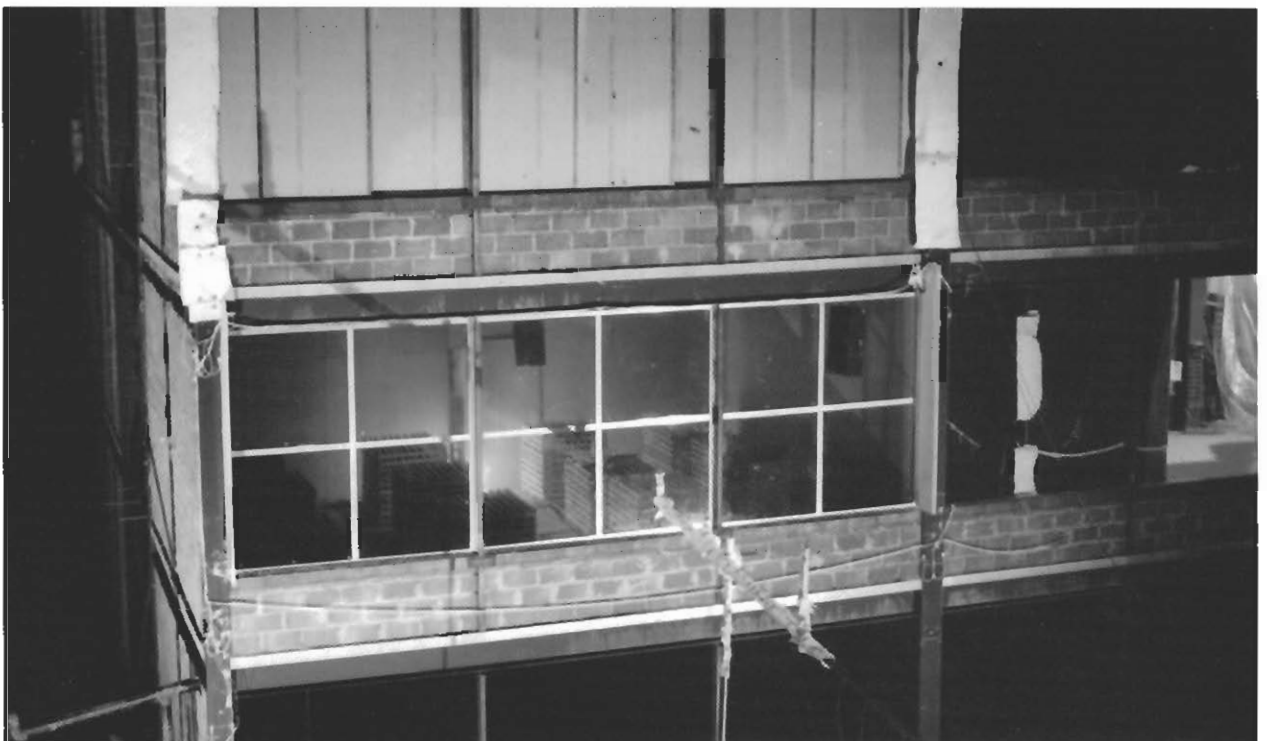
**Figure 6.25** Start of fire test 4

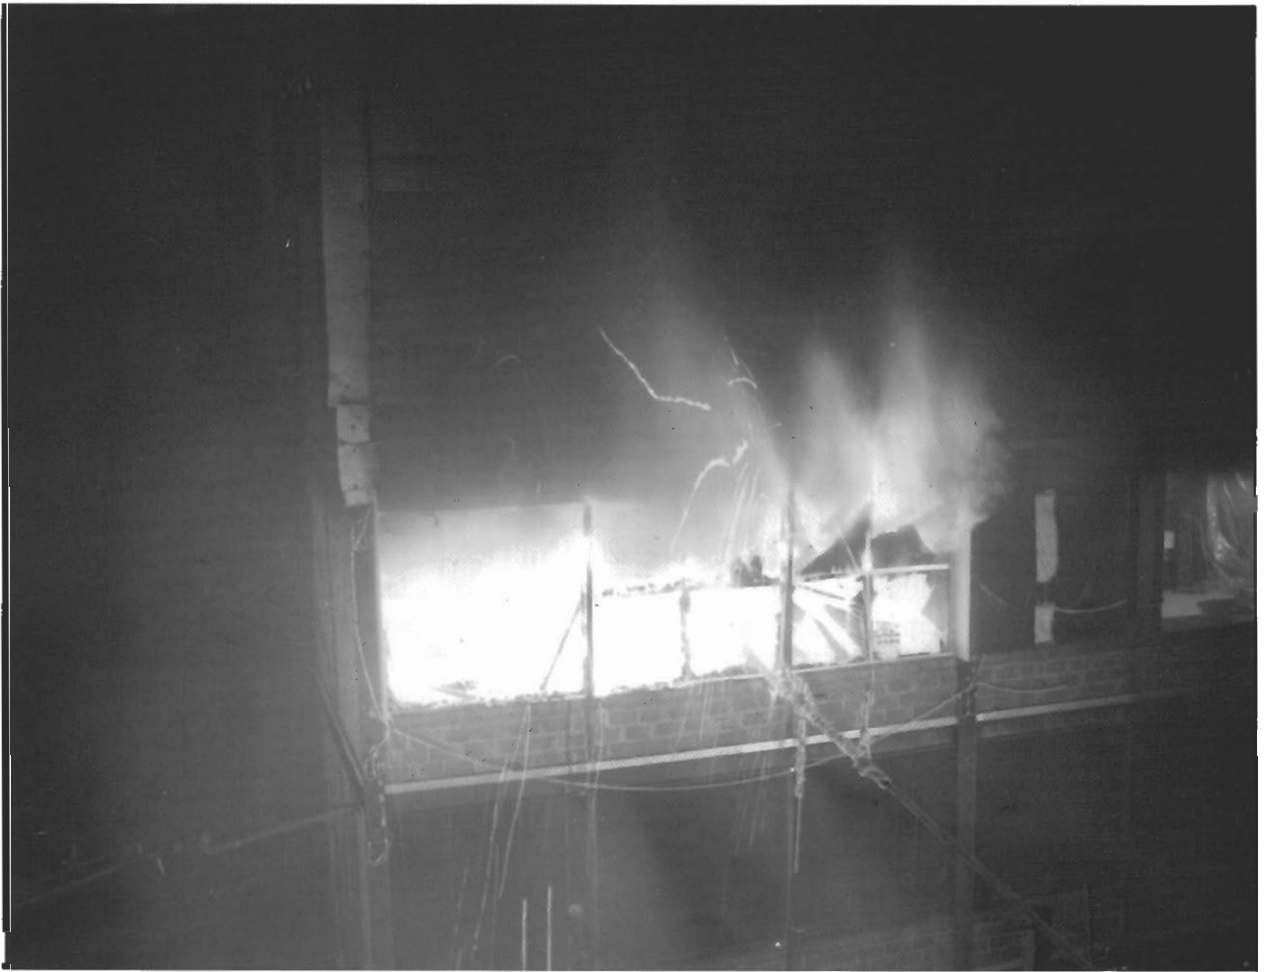
**Figure 6.26 (a)**      *Fire test in progress*

The unprotected edge beam was observed during the test to be completely engulfed in fire (Figure 6.26). However, the maximum temperature of this beam only reached 680°C, with a corresponding maximum displacement of 52mm, recorded after 114 minutes (Figure 6.29). Even with lower temperatures, compared to the internal beams, the displacement of the edge beam was very small. This was attributed to the wind posts above the compartment, which acted in tension during the test, providing support to the heated

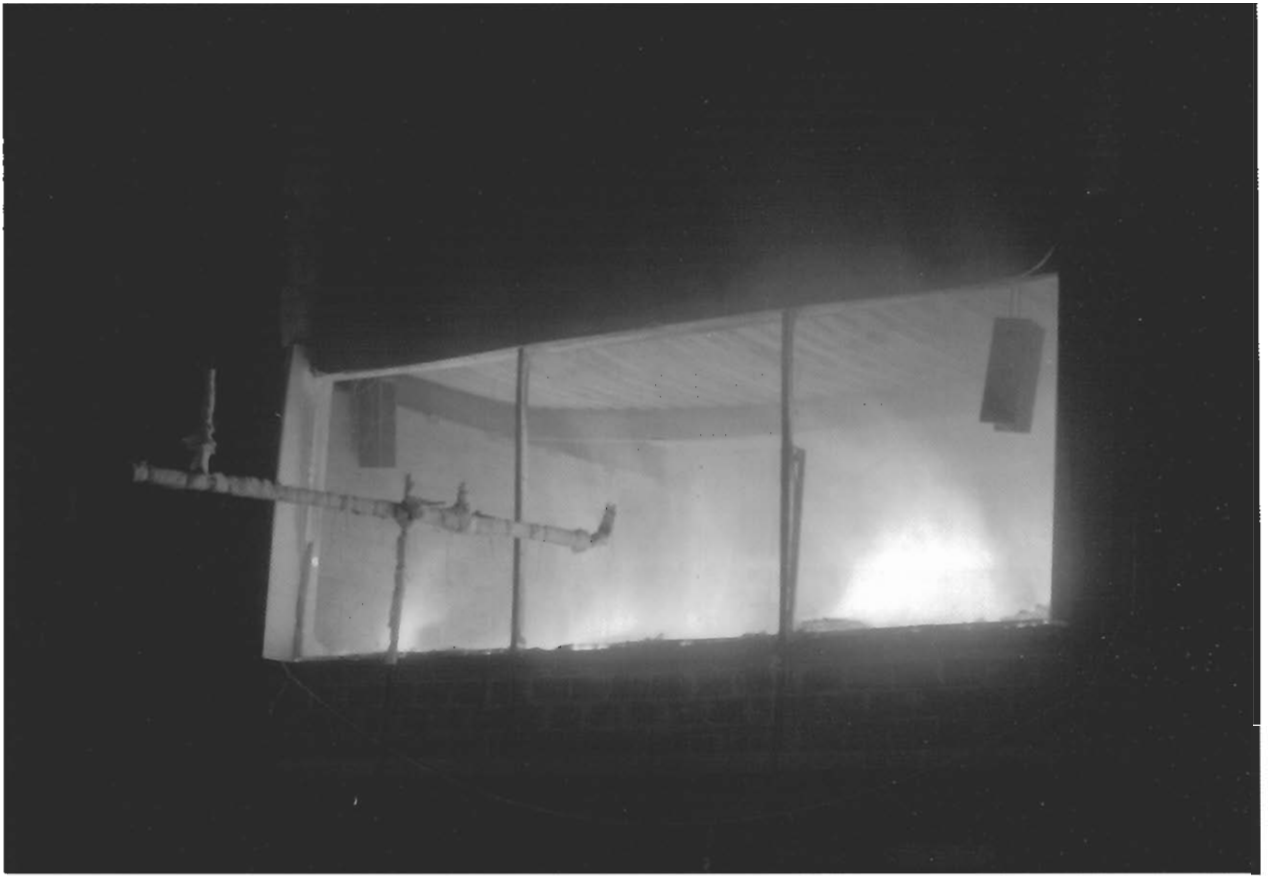
**Figure 6.26 (b)** *Fire test in progress*

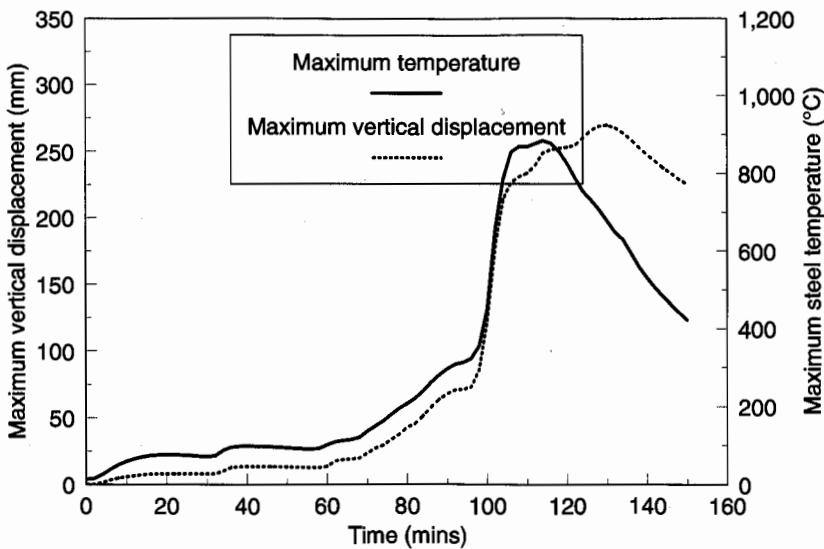
**Figure 6.28** Recorded vertical displacement and temperature of the secondary beam at the centre of the fire compartment

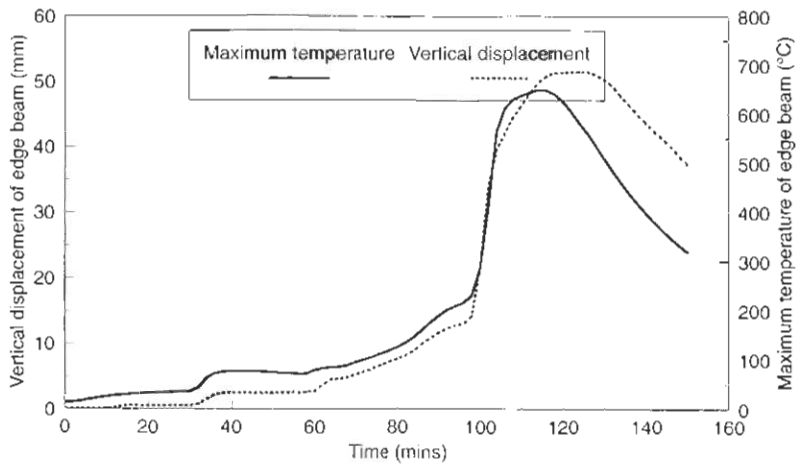
**Figure 6.29** Maximum vertical displacement and temperature of edge beam

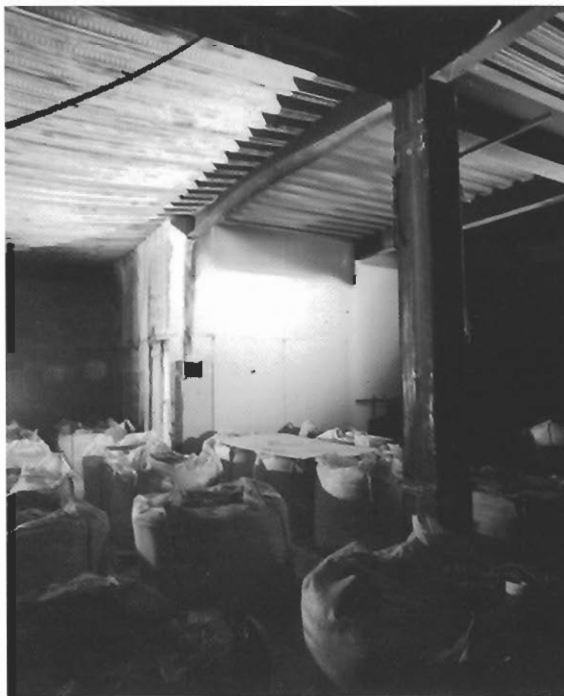
**Figure 6.32** Distortional buckling of the beam above the compartment wall (after removal of the wall)

ISO 834 test. However, it is of interest to notice how well the compartment wall performed (Figure 6.31), with its integrity being maintained for the duration of the test. On removal of the wall it could be seen that the beam had distortionally buckled over most of its length (Figure 6.32). This was caused by the high thermal gradient through the cross-section of the beam (caused by the positioning of the compartment wall), together with high restraint to thermal expansion.

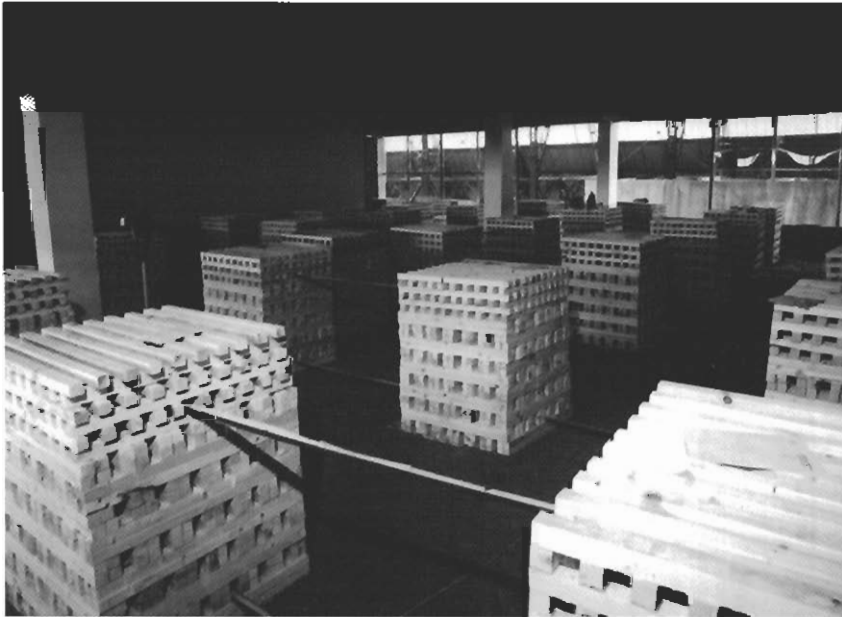
**Figure 6.34** Timber cribs within the compartment

The fire load of 40kg/m<sup>2</sup> was provided by timber cribs arranged uniformly over the floor area (Figure 6.34). The compartment was constructed by erecting a fire resistant wall across the full width of the building and by constructing additional protection to the lift shaft. Double glazing was installed on two sides of the building on gridlines 1 and 4. To allow sufficient ventilation for the fire to develop the middle third of the glazing on both sides of the building was left open. All the steel beams, including the perimeter beams, were left unprotected. The internal and external columns were protected up to and including the connections.
