# THE BEHAVIOUR OF MULTI-STOREY STEEL FRAMED BUILDINGS IN FIRE

A European Joint  
Research Programme

ISBN 0 900206 50 0

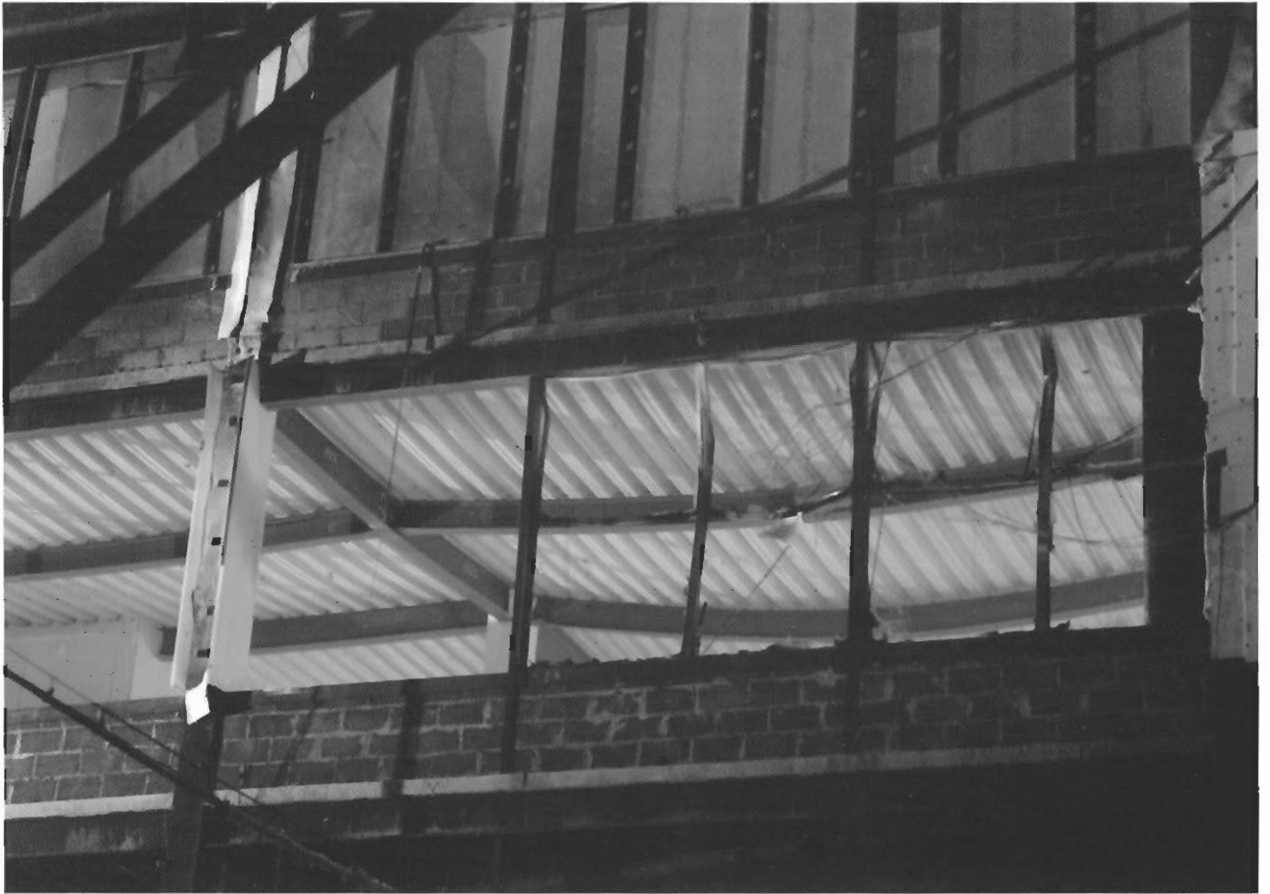
**Figure 6.37** Structural behaviour towards the end of the test (notice the local buckling on the second internal secondary beam)

Figure 6.37 shows the structural response in the latter stages of the fire. It can be seen that the structure performed very well with stability and integrity of the compartment being maintained during the heating stage of the fire. However, the fire was not very severe, with a maximum recorded steel temperature of 691°C.

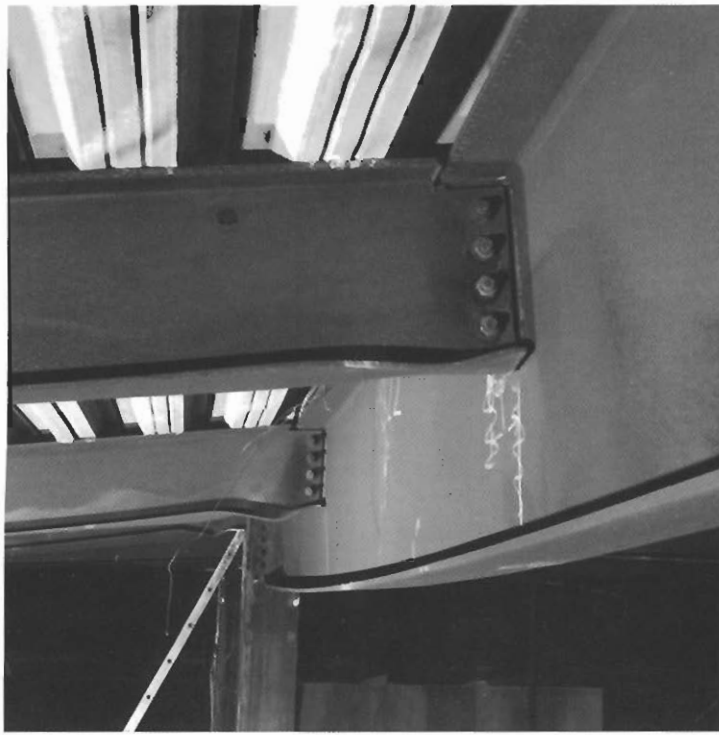
**Figure 6.38** *Local buckling in the proximity of the steel-to-steel connections*

Extensive local buckling occurred in the proximity of the beam-to-beam connections (Figure 6.38). On cooling a number of the end-plate connections fractured down one side; in one instance the web detached itself from the end-plate (Figure 6.39).

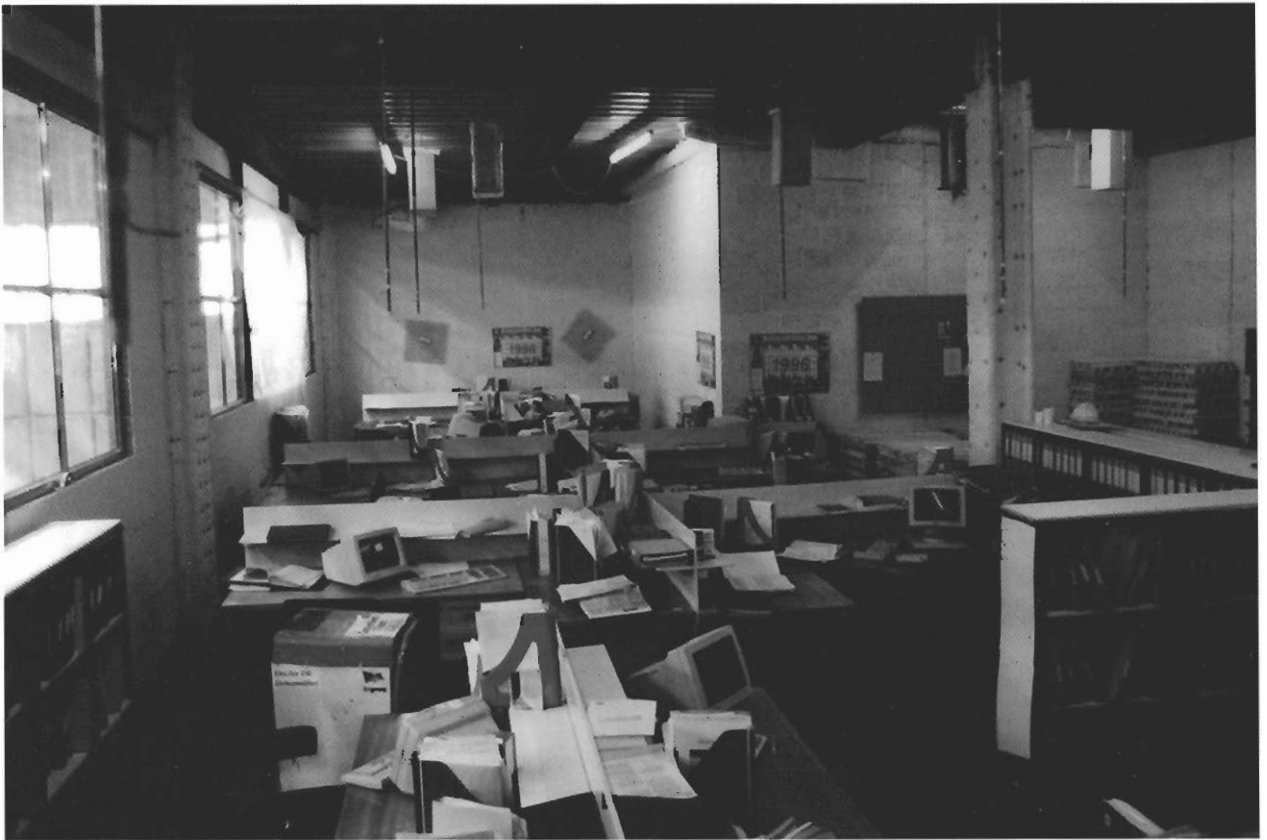
**Figure 6.41** Internal view of the compartment

A compartment 18m wide and up to 10m deep with a floor area of 135m<sup>2</sup> was constructed between the first and second floors, using concrete blockwork. A gap of approximately 250mm was left between the top of the blockwork and underside of the steel decking, together with slots around the steel beams, to allow the heated structure to deform freely. These gaps were filled with an insulating ceramic fibre blanket. The design of the compartment was such that it represented an open plan office (Figure 6.40) and contained a series of work stations consisting of modern day furnishings, computers and filing systems (Figure 6.41).

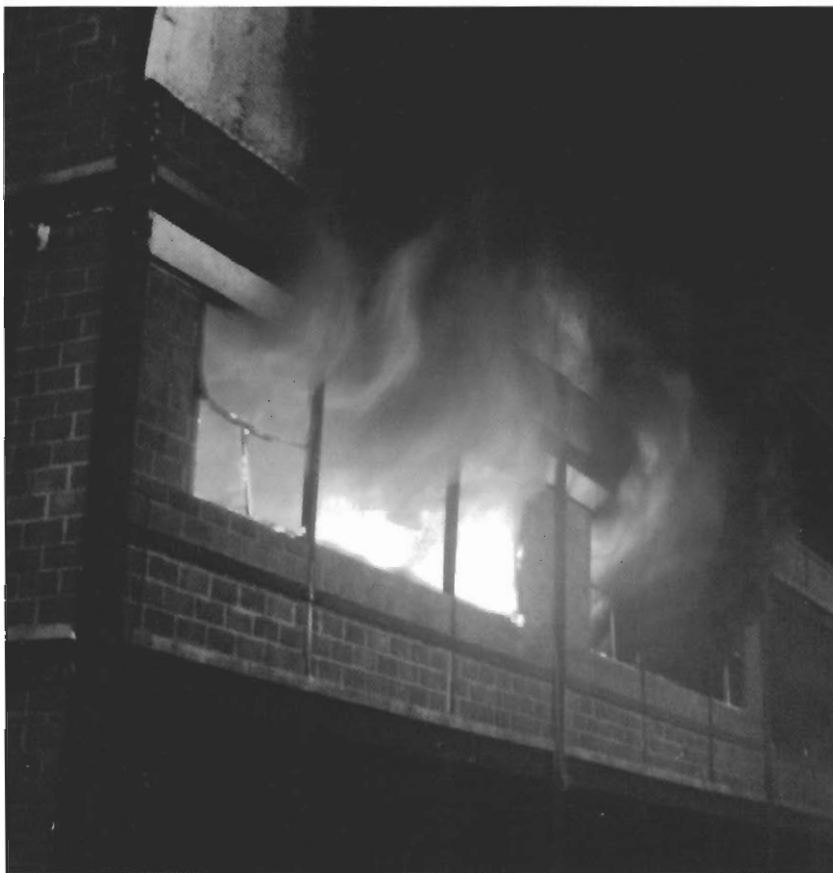
**Figure 6.43** Test 6 at the height of the fire

Within 10 minutes of ignition, local atmosphere temperatures were in excess of 900°C. The recorded maximum atmosphere and unprotected steel temperatures were 1213°C (Figure 6.42) and 1150°C respectively. At the height of the fire (Figure 6.43), the calculated heat release rate was 58MW. A maximum vertical displacement of 640mm was recorded after 62 minutes (Figure 6.44)

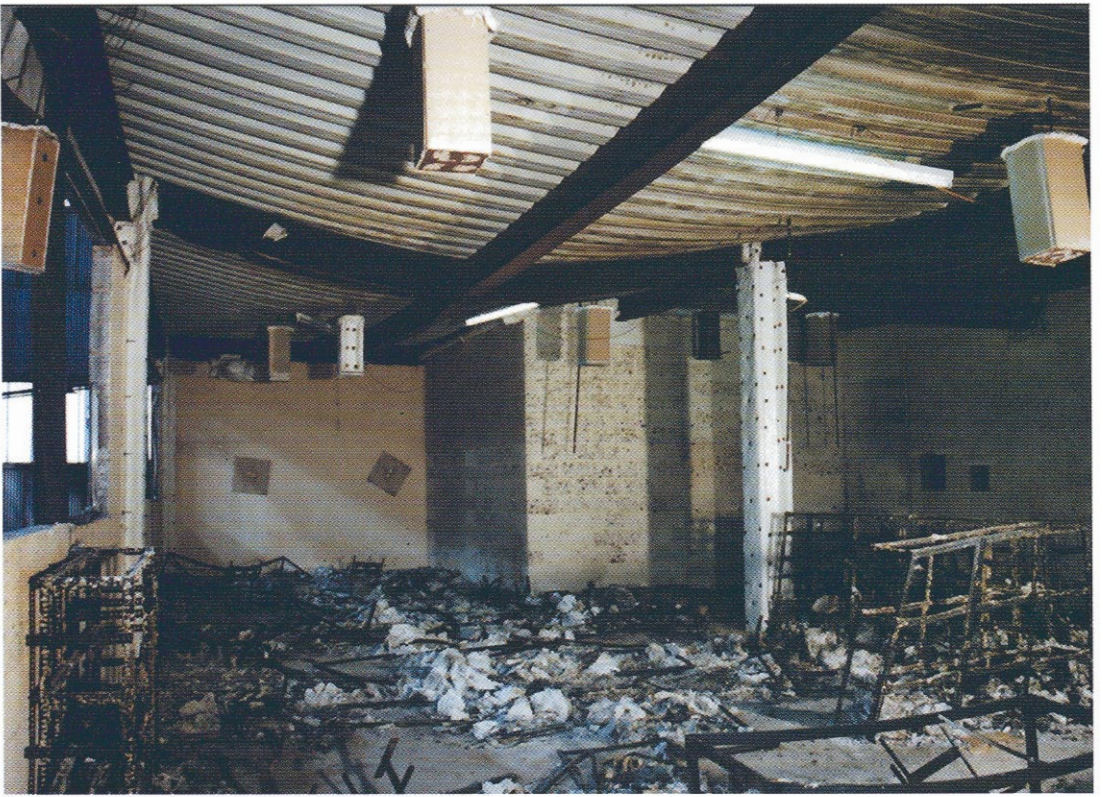
**Figure 6.45** *Internal view of compartment following the test*

All the combustible material in the compartment was consumed (Figure 6.45) including the contents of the filing cabinets. From the temperatures measured by protected indicative specimens suspended from the floor slab, the fire severity was found to be equivalent to 74 minutes in the standard fire resistance test.

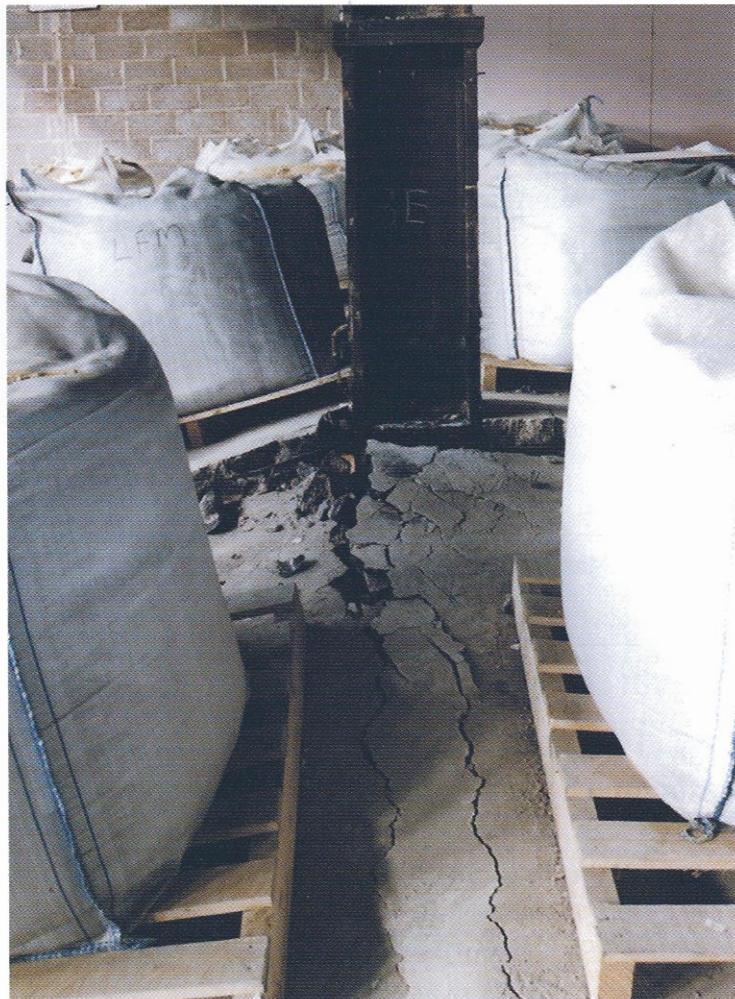
**Figure 6.46** *Cracking of the composite slab around internal column*

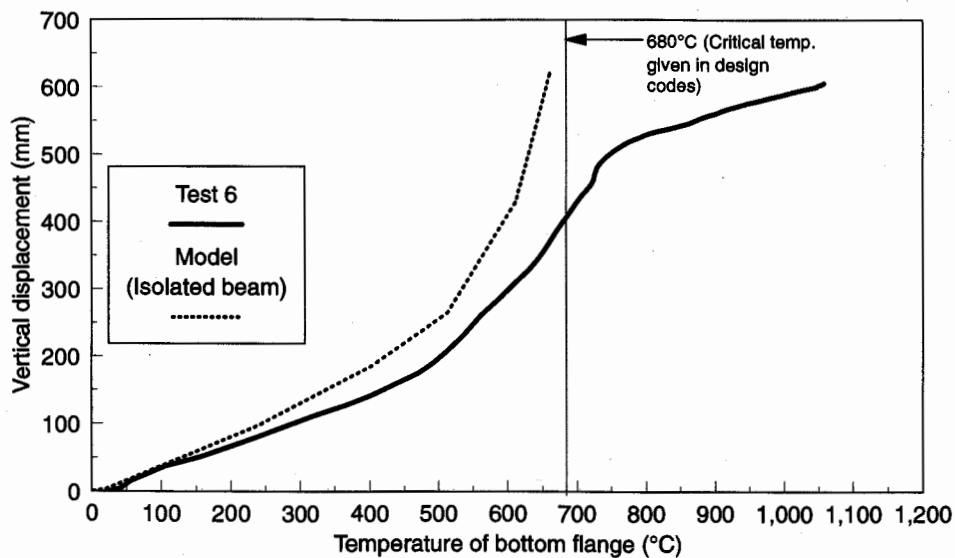
**Figure 7.5** Comparison between beam in Test 6 and beam modelled as an isolated member
