TEESSIDE LABORATORIES

Report No	T/RS/1189/28/82/C
Date	28 APRIL 1982
Classification	OPEN

**The Fire Resistance of an Unprotected Steel
Column Built into a Fire Resistant Wall**

British Steel Corporation

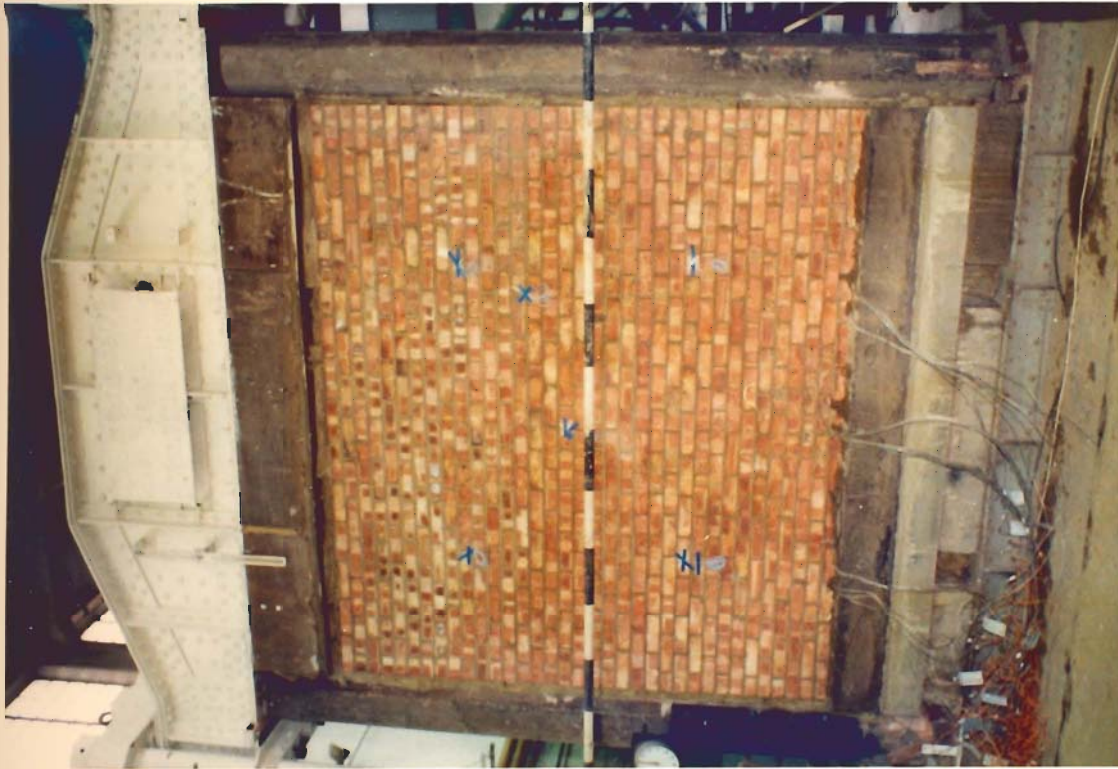
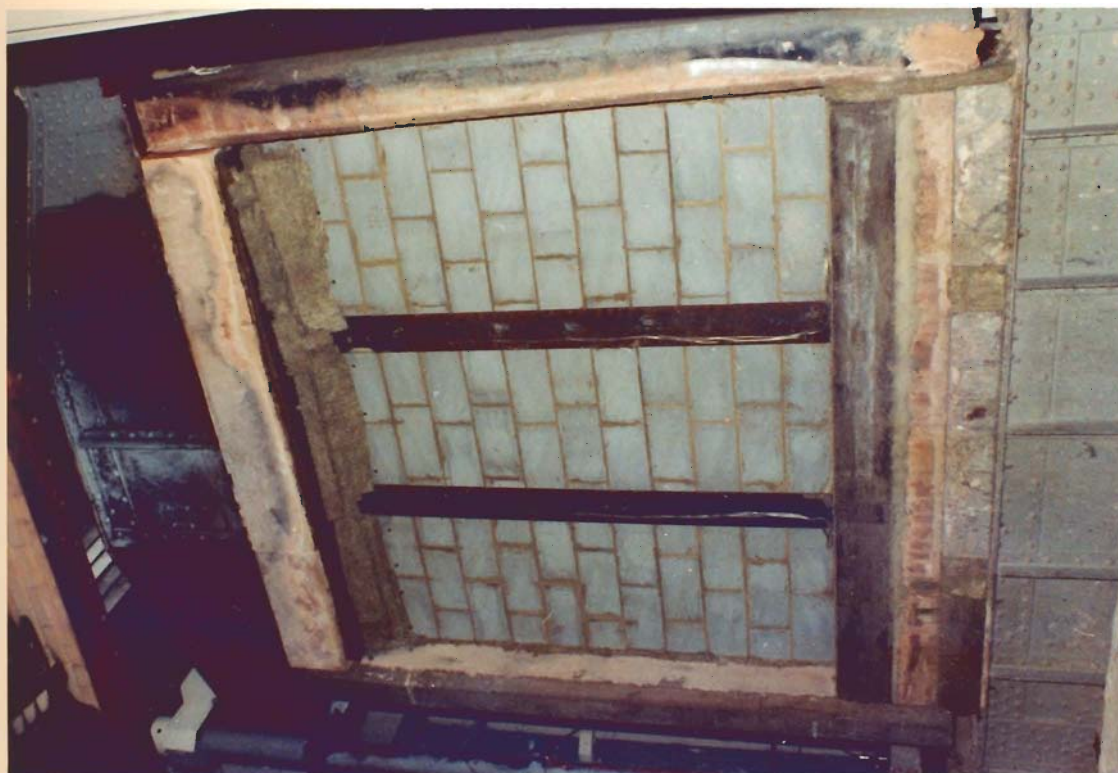
FIGURE 2.

UNEXPOSED SIDE OF CONSTRUCTION

SIDE EXPOSED TO FURNACE ATMOSPHERE

FINAL CONSTRUCTION POSITIONED IN FURNACE SHOWING THE EXPOSED AND UNEXPOSED SIDES

The outer 62.5 mm of web and flange was exposed to the fire. Figures 1-6 show the details of the construction. Figure 1 shows columns and baseplates in the early stages of fabrication, and Figure 2 shows the final wall on the furnace and unexposed sides of the structure. Figures 3 and 4 are diagrams of the construction used showing precise details of the location of steel, bricks and blocks.

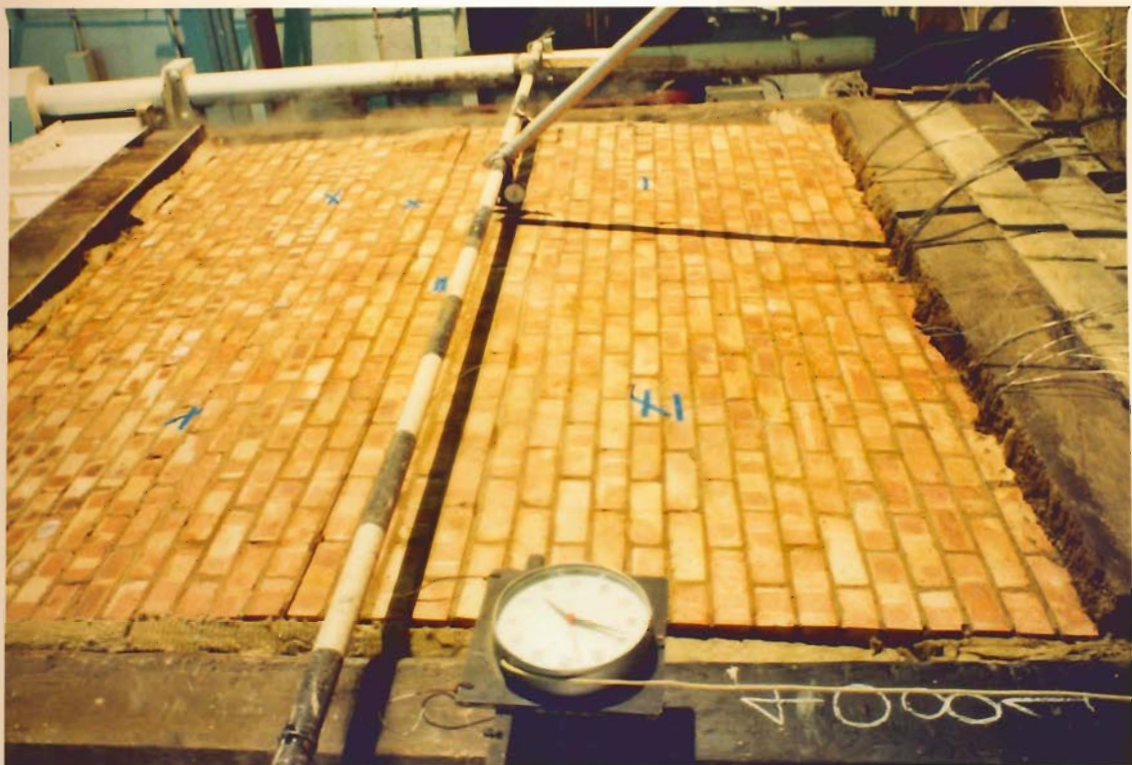
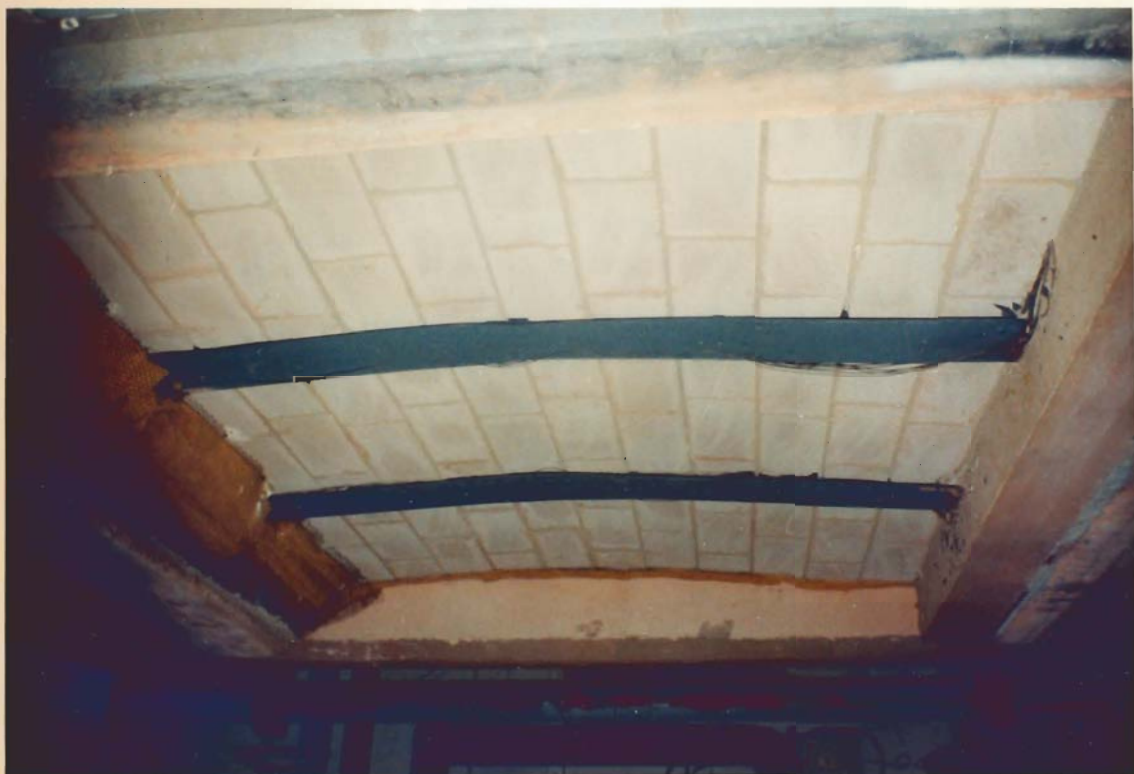
FIGURE 7.

THE WALL AT THE END OF THE TEST

The test was discontinued after 103 minutes, when it was thought that the outer Fletton brick wall was on the point of collapse. Two large horizontal cracks were present in the wall at the end of the test, and significant deformation was apparent so that collapse may have occurred in a sudden and catastrophic manner.

Figure 7 is a photograph of the wall at the end of the test showing the deformation of the wall/column construction.

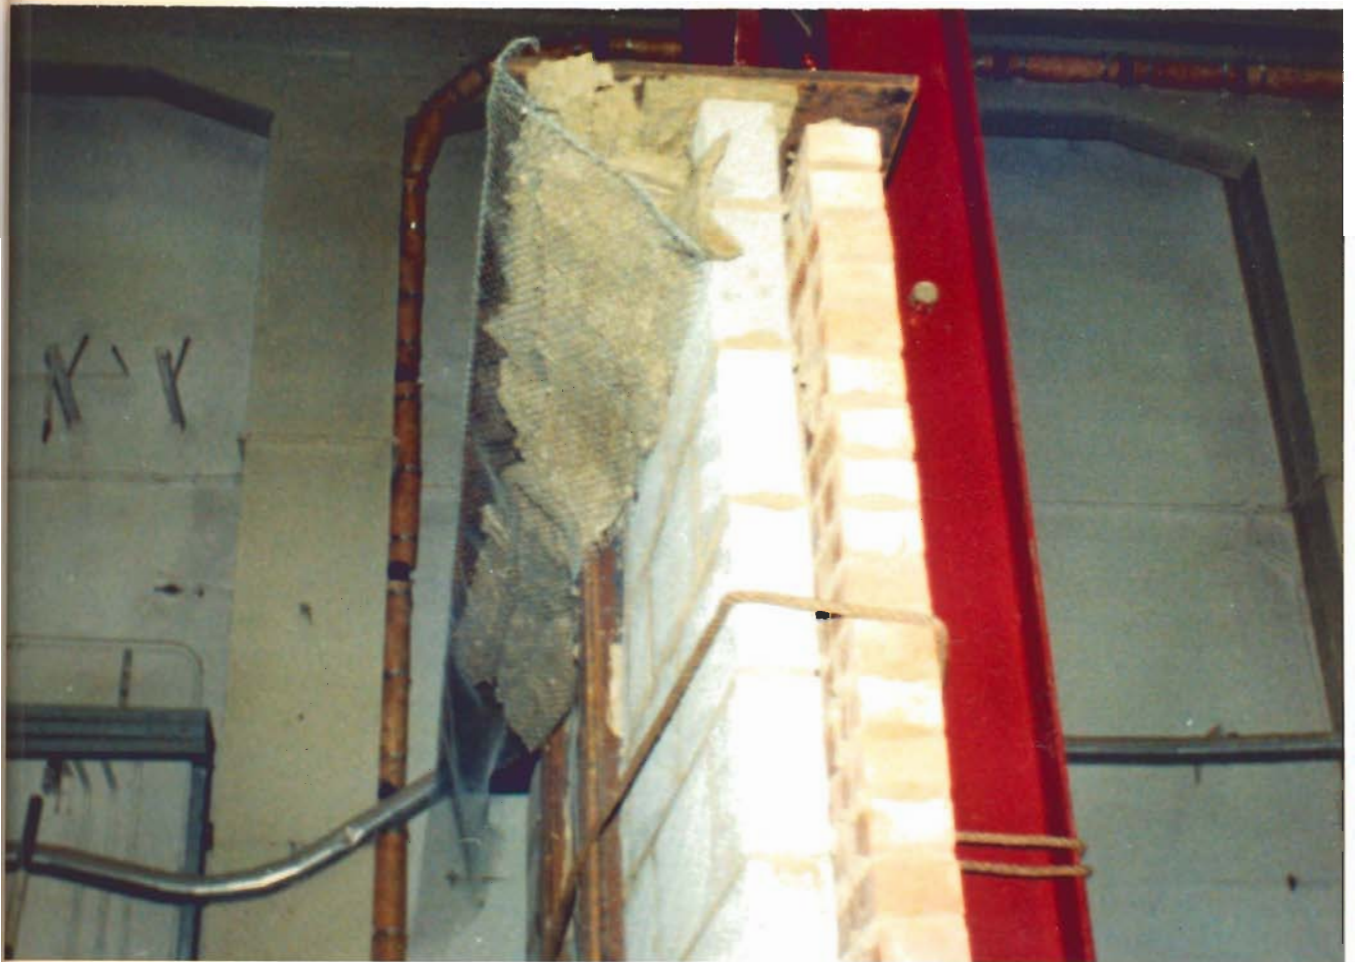
FIGURE 6.

CONSTRUCTION OF CHICKEN MESH AND MINERAL WOOL
TO PROTECT UPPER PLATE

To protect the upper restraining plate during the fire test, the chicken wire mineral wool arrangement, shown in Figures 5 and 6, was constructed.

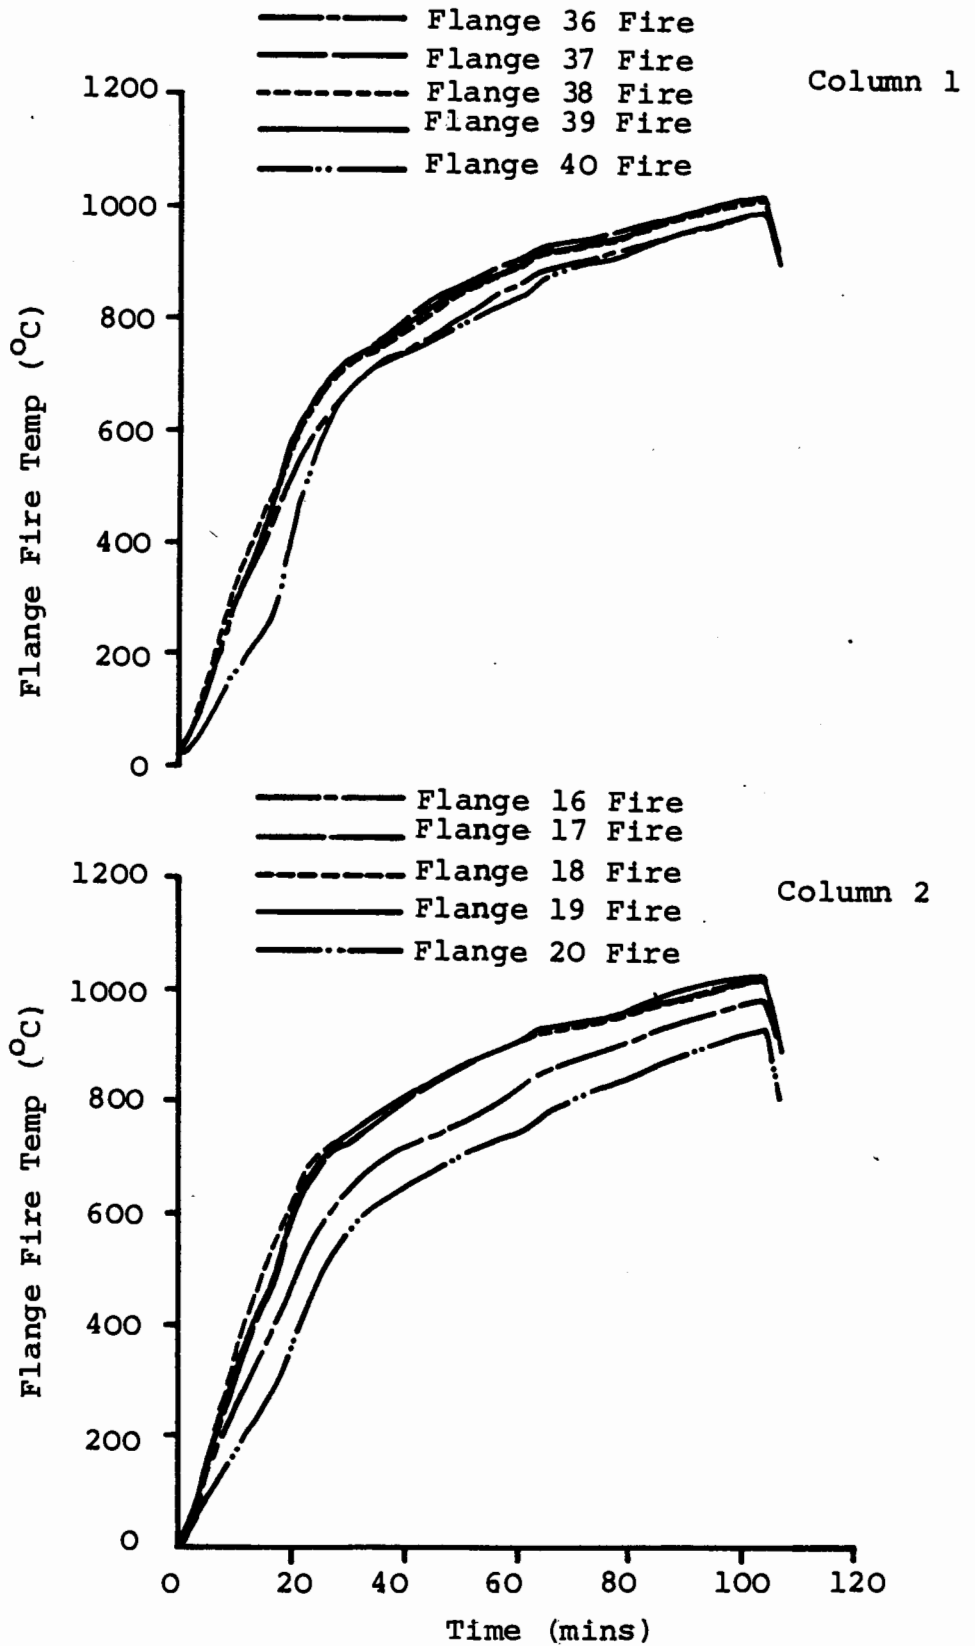
TEMPERATURES RECORDED ON THE OUTER FLANGES OF BOTH COLUMNS

The results of temperature measurement are shown in Figures 9-13.

At the end of the test the outer flanges of both columns were heated to temperatures in the range 925-1026°C, whilst the concealed flanges were much cooler with temperatures in the range 149-322°C.

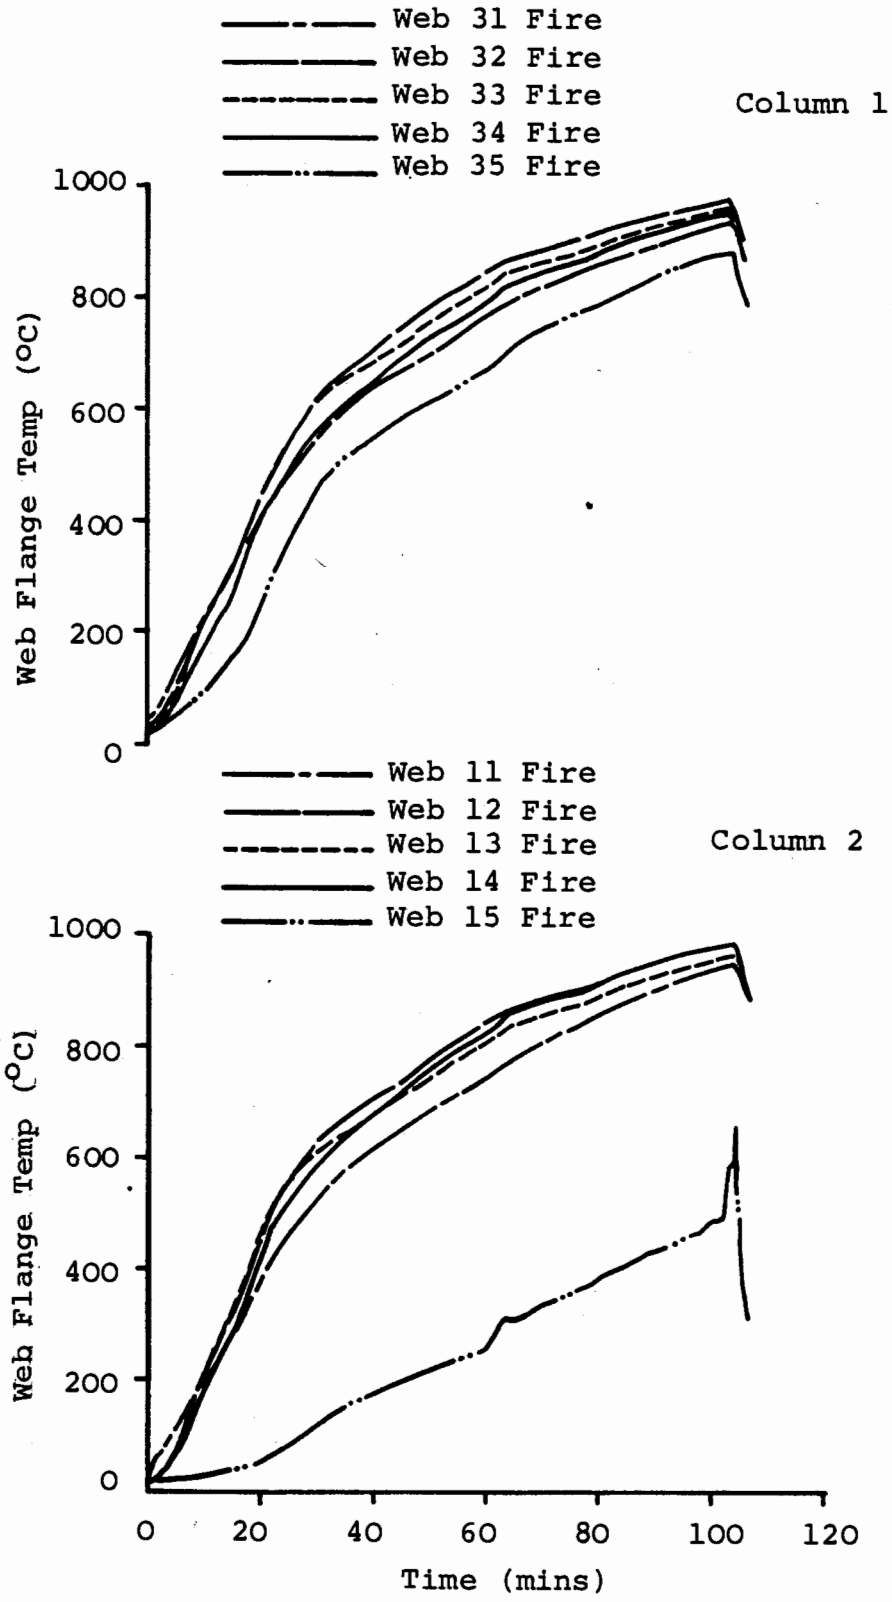
FIGURE 10

TEMPERATURES RECORDED ON THE OUTER WEBS OF BOTH COLUMNS

At the exposed web measurement location temperatures were in the range 882-985°C, whilst in the inner web location temperatures were within the range 233-512°C.

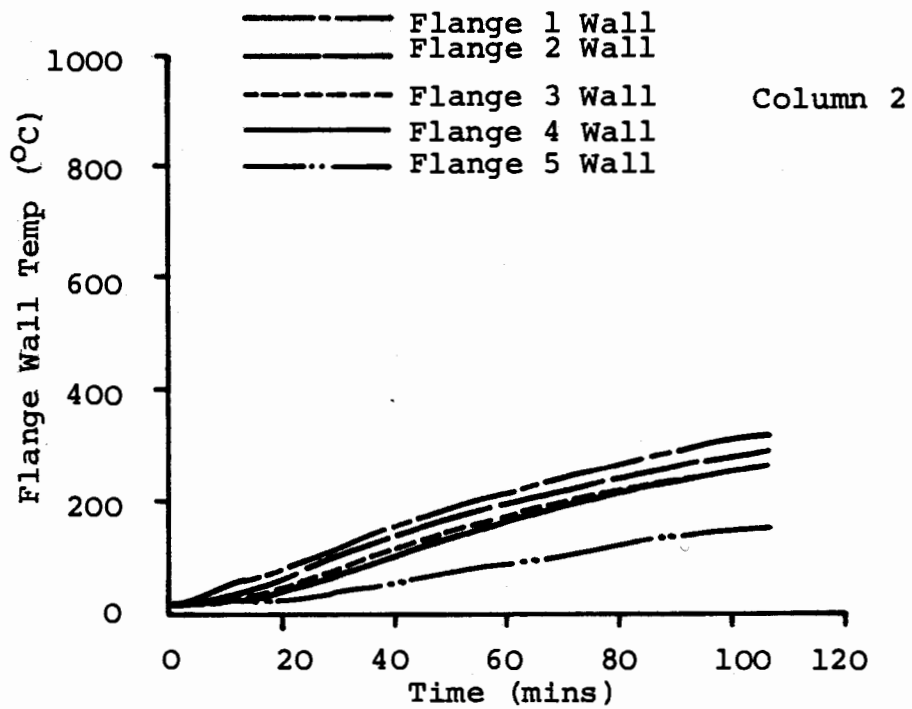
FIGURE 1

TEMPERATURES RECORDED ON THE INNER FLANGES OF BOTH COLUMNS

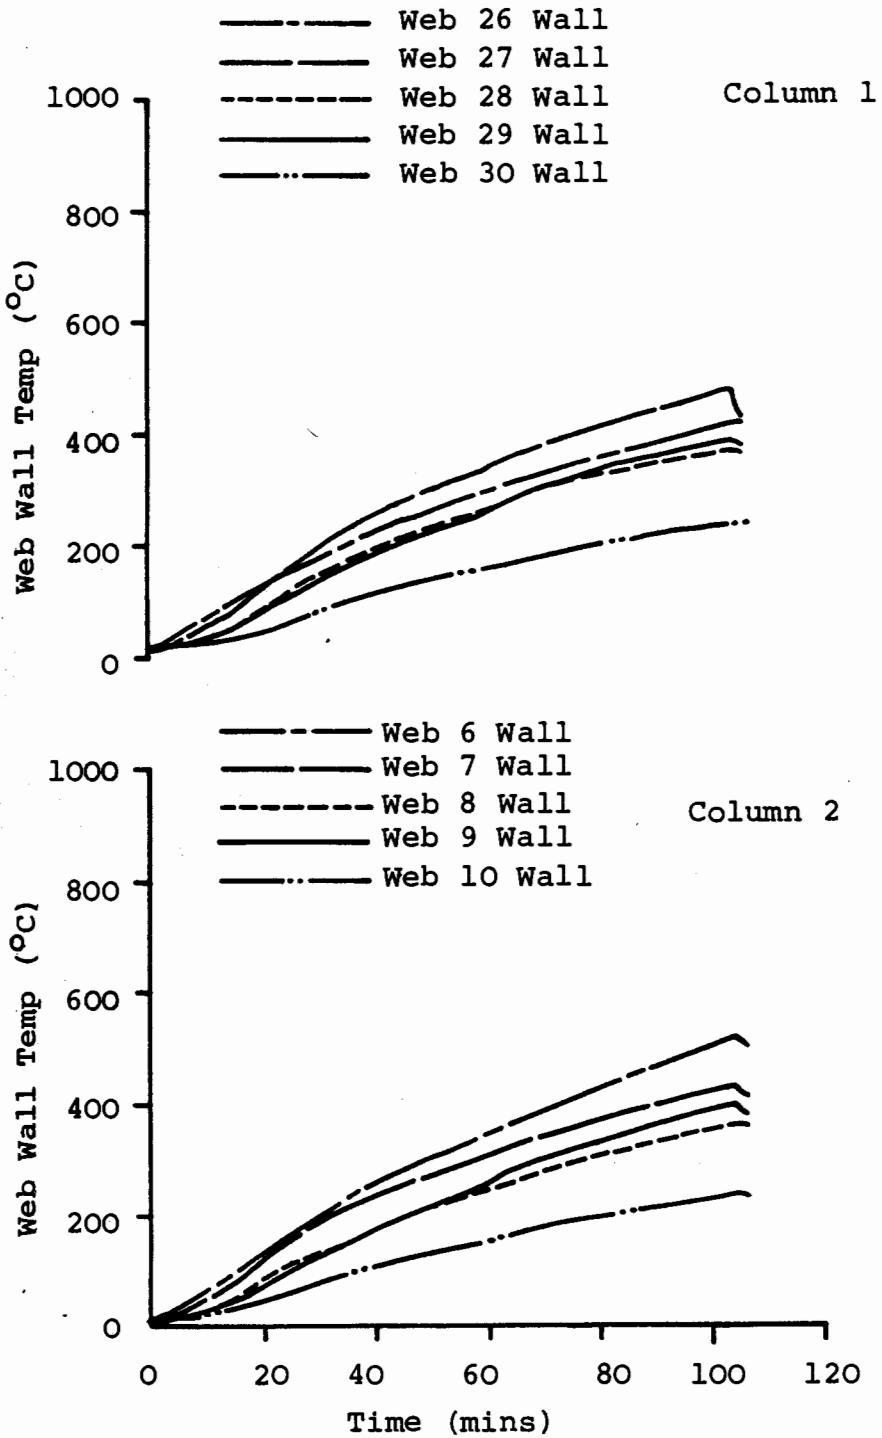
FIGURE 12

TEMPERATURES RECORDED ON THE INNER WEBS OF BOTH COLUMNS

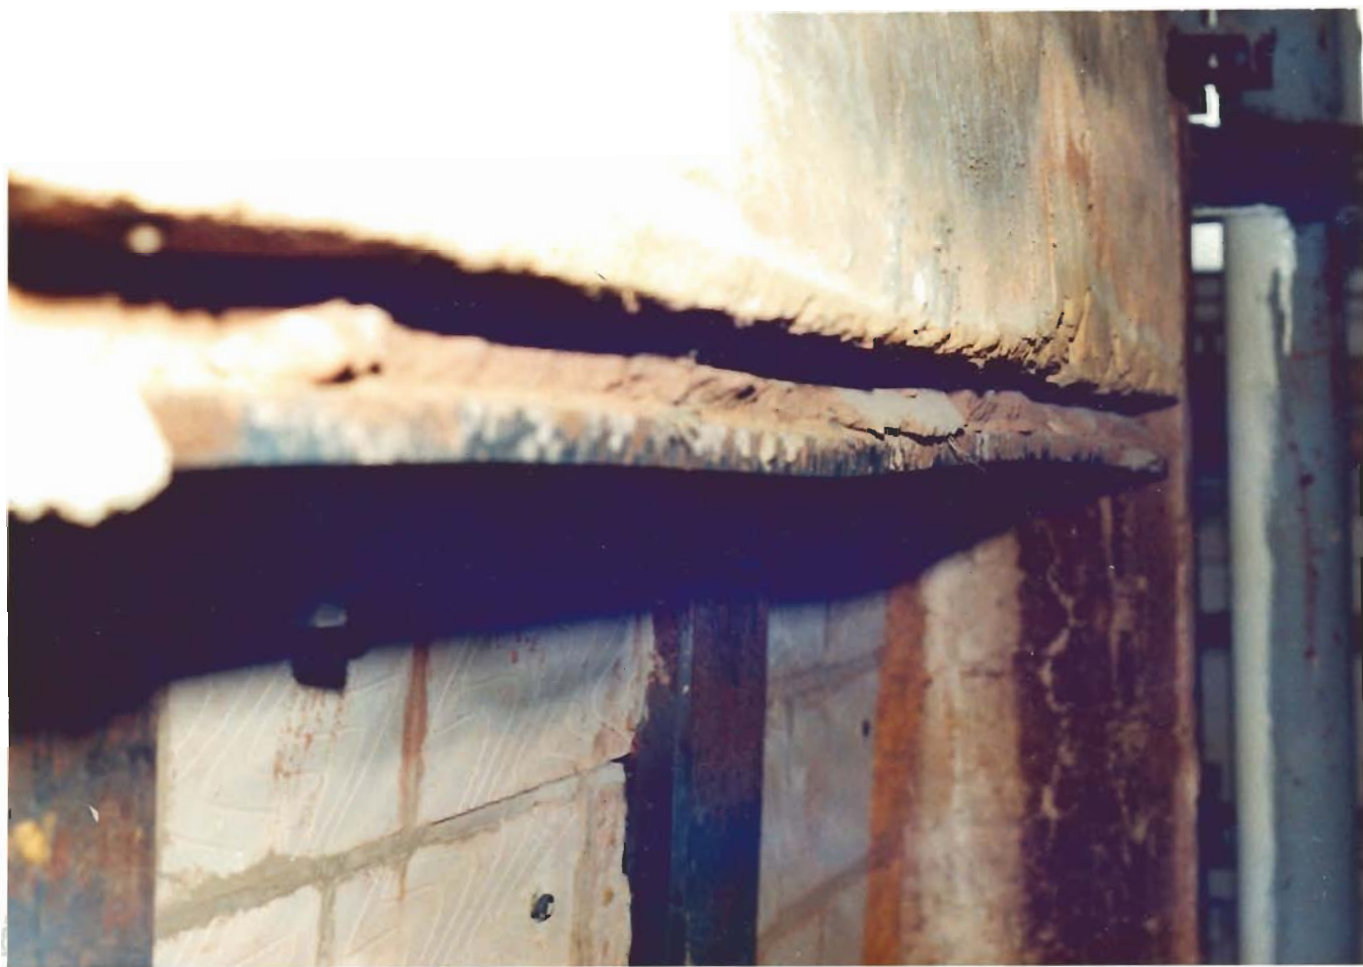
FIGURE 14.

TOP OF THE SPECIMEN AFTER THE TEST, AND REMOVAL OF THE
MINERAL FIBRE PROTECTION. NOTE THE GAP BETWEEN THE STEEL
PLATE AND THE FURNACE FRAME

Following the test, detailed observations were made of the extent of deformation of the columns and the relative positions of the upper plate and the block and brick walls.

A photograph of the top of the construction after the test is shown in Figure 14.
