Report No.	SL/LP/R/S2348/1/93/D
Date	2 February 1993
Classification	CONFIDENTIAL

## The Evaluation of Two Fire Tested Concrete Filled Hollow Circular Sections

I.M. Gaunt, D.J. Latham and J.A. Chapman

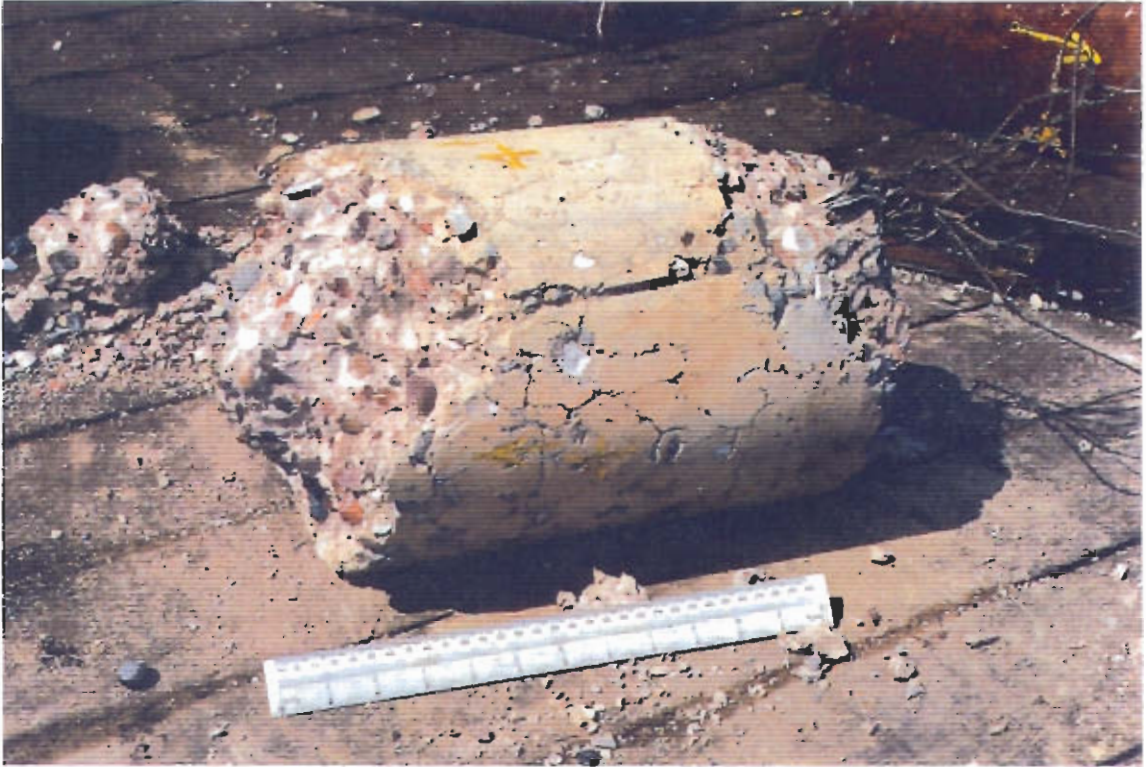
**FIG. 5 244.4 mm OD COLUMN, (CODE NO. 1M49D), SECTION 4**

With the exception of the sections close to the fracture, most of the concrete core appeared to be intact when the steel casing was removed. The surface of the concrete was buff coloured and contained a large number of cracks, as shown in Fig. 5. When the concrete was sectioned, two areas of cracking were evident. The concentration of surface cracks extended approximately 20 mm below the surface, whilst a lower concentration of cracks extended to approximately 50 mm below the surface - the same depth as the discolouration. The discoloured layer, which is probably caused by the temperature of the concrete exceeding the 300°C value above which the silica hydrates begin to decompose, was readily identified, particularly when the surface of the concrete was wet. A remnant central zone of the concrete, approximately 130 mm diameter, appeared to be intact and unaffected by discolouration or cracking but, on handling, a large number of cracks began to open and it was apparent that, along much of the column, the centre of the concrete core had little strength. The concrete near the ends of the column appeared to have been less affected because there was no discolouration, negligible surface cracking was evident and the centre of the concrete core had a higher strength. The precise point at which the concrete began to show signs of degradation was difficult to isolate but appeared to lay within section one at the top of the column and within section seven at the bottom of the column.

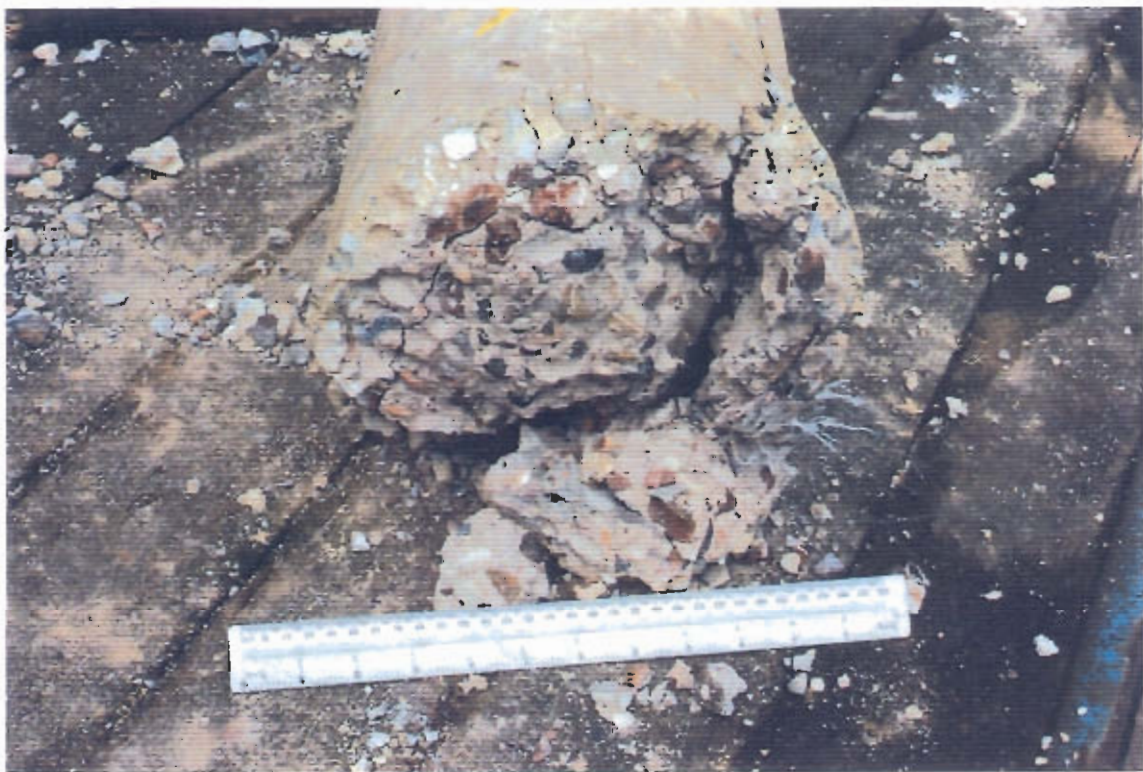
FIG. 6 244.4 mm OD COLUMN, (CODE NO. 1M49D), SECTION 6

The appearance of the concrete in cross-section is shown in Fig. 6 and the discolouration and surface cracking is shown schematically in Fig. 7. An example of the cracking through the centre of the concrete core is shown in Fig. 8.

Examination of the cross-section of the concrete core of this column shows a depth of discolouration of approximately 50 mm. If this is related to the position of the thermocouples, shown in Fig. 13, and to the thermocouple traces shown in Appendix 2, the measured temperatures appear to correlate well with the 300°C temperature contour marking the limit of the discolouration observed on the cross-section of the core.
