# STRUCTURAL FIRE ENGINEERING

## INVESTIGATION OF BROADGATE PHASE 8 FIRE

#### EXECUTIVE SUMMARY

On the 23rd June, 1990 a fire developed in the partly completed fourteen storey building in the Broadgate development.

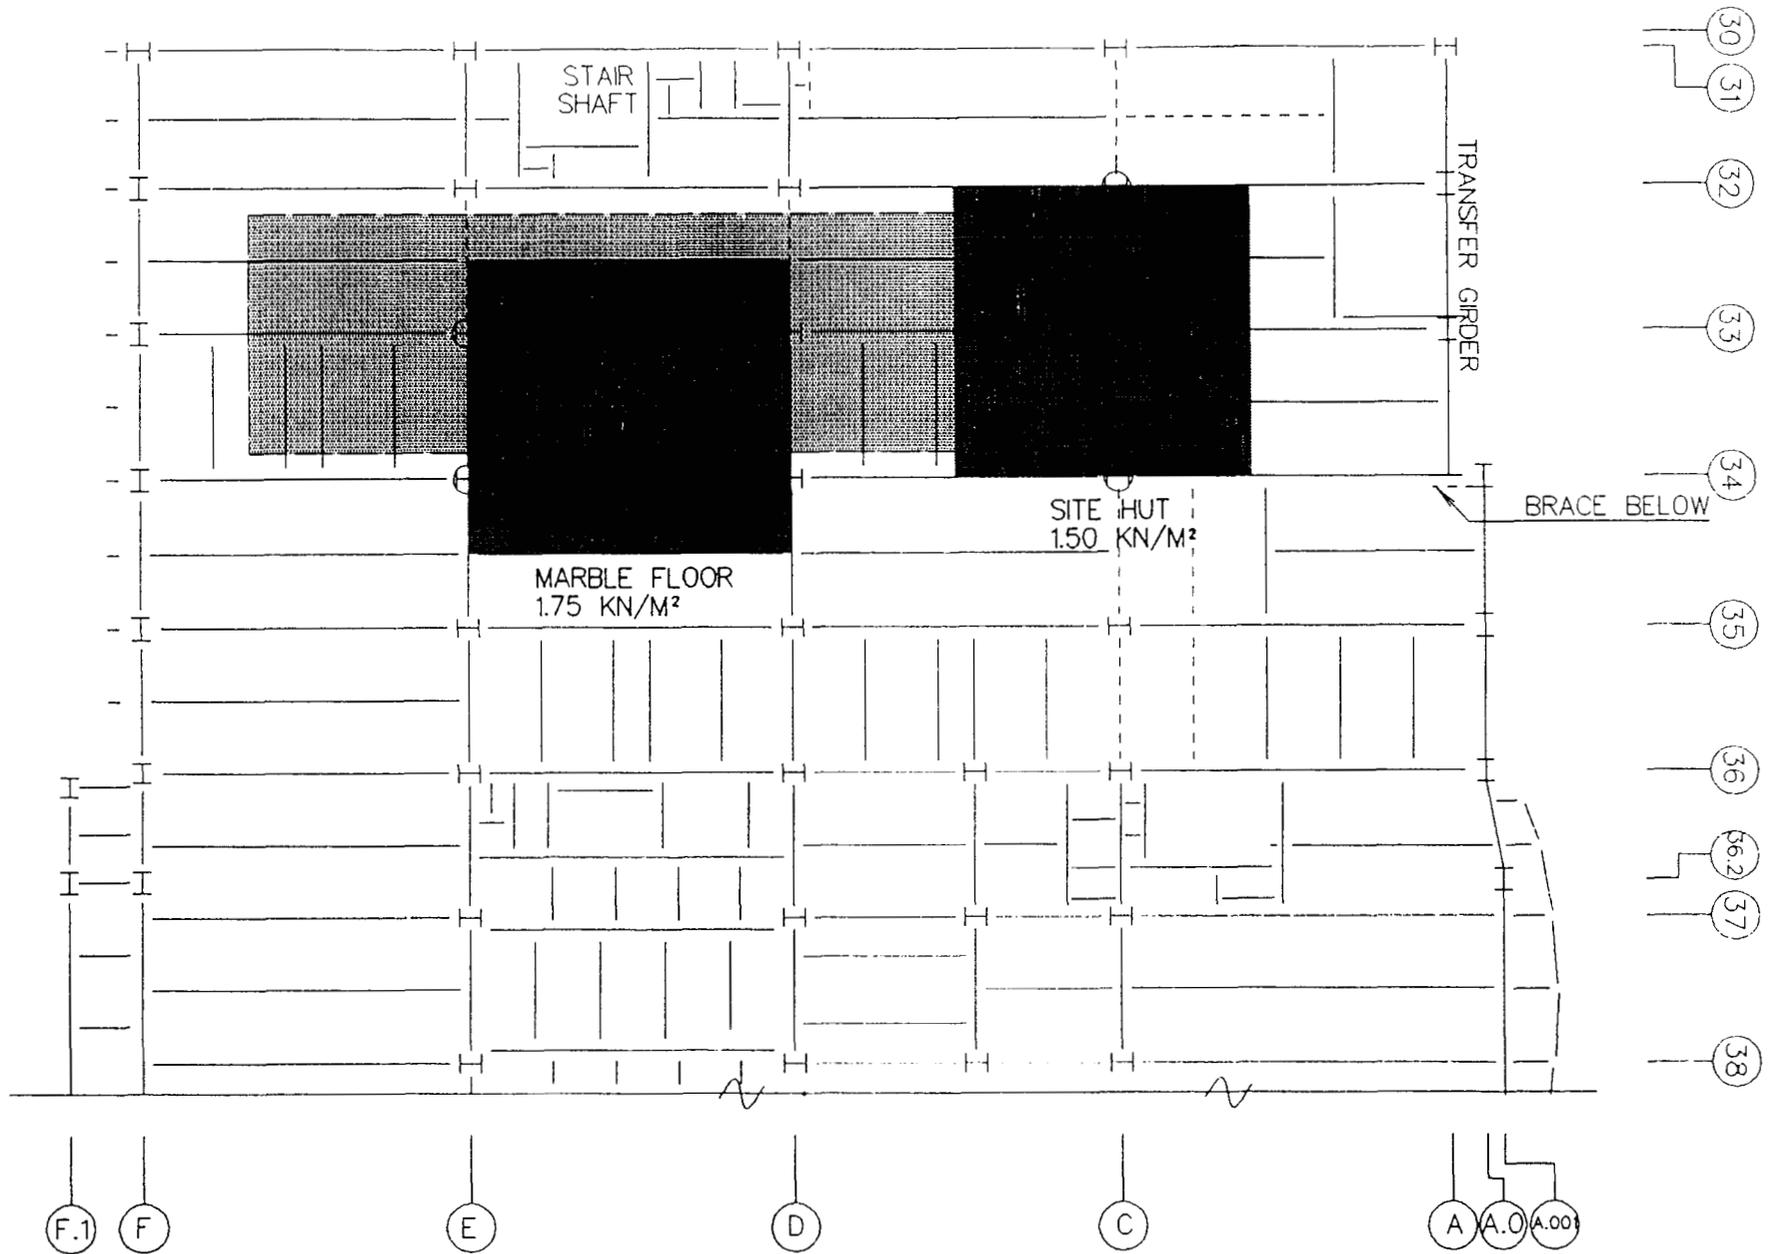
Figure 6: Superimposed Loads at Level 2 During Fire

The building was "lightly loaded" when the fire occurred. It was unoccupied by tenants, and consequently the loads imposed by the contents of the building were lower than the design values. The positions and additional weight from an atrium floor, and a sub-contractor's hut on the floor above are noted in Figure 6. Detailed surveys of the building were conducted following the fire and Figure 7 shows the deflection in the slab; Figure 8 shows the position of cracks in the floor slab; and Figure 9 shows the positions of the bolts connecting beams and columns which were subsequently tested by British Steel.

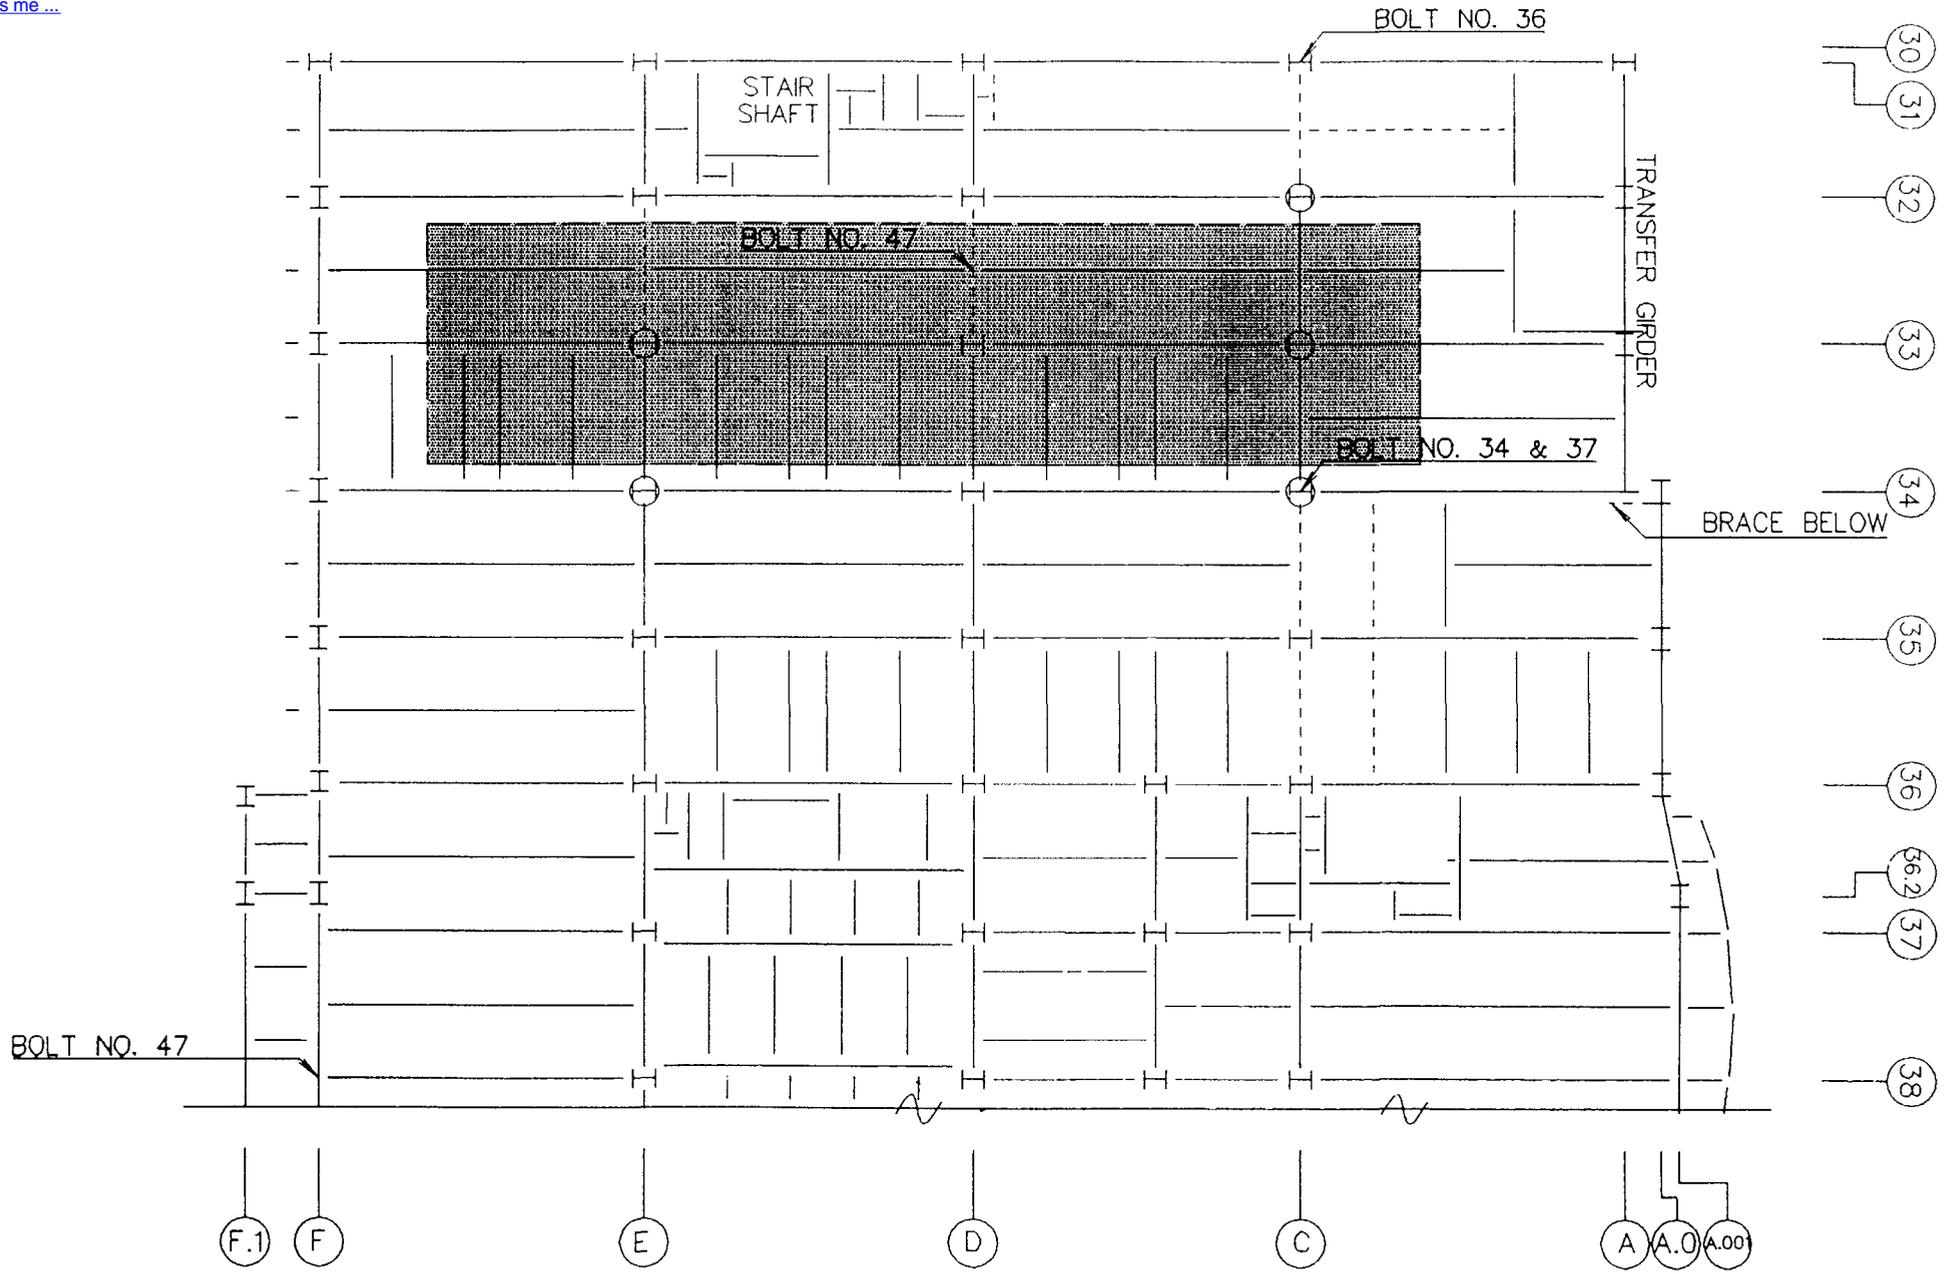
Figure 9: Plan Level 2 showing positions of bolts used in British Steel's investigation

British Steel Swinden Laboratories have carried out a metallurgical evaluation in an attempt to establish the temperatures achieved by several quenched and tempered bolts recovered from the building (7). The bolts had previously been tested by Stangers. The table below shows their strength properties as determined by Stangers. Figure 9 shows the positions of the bolts within the building.

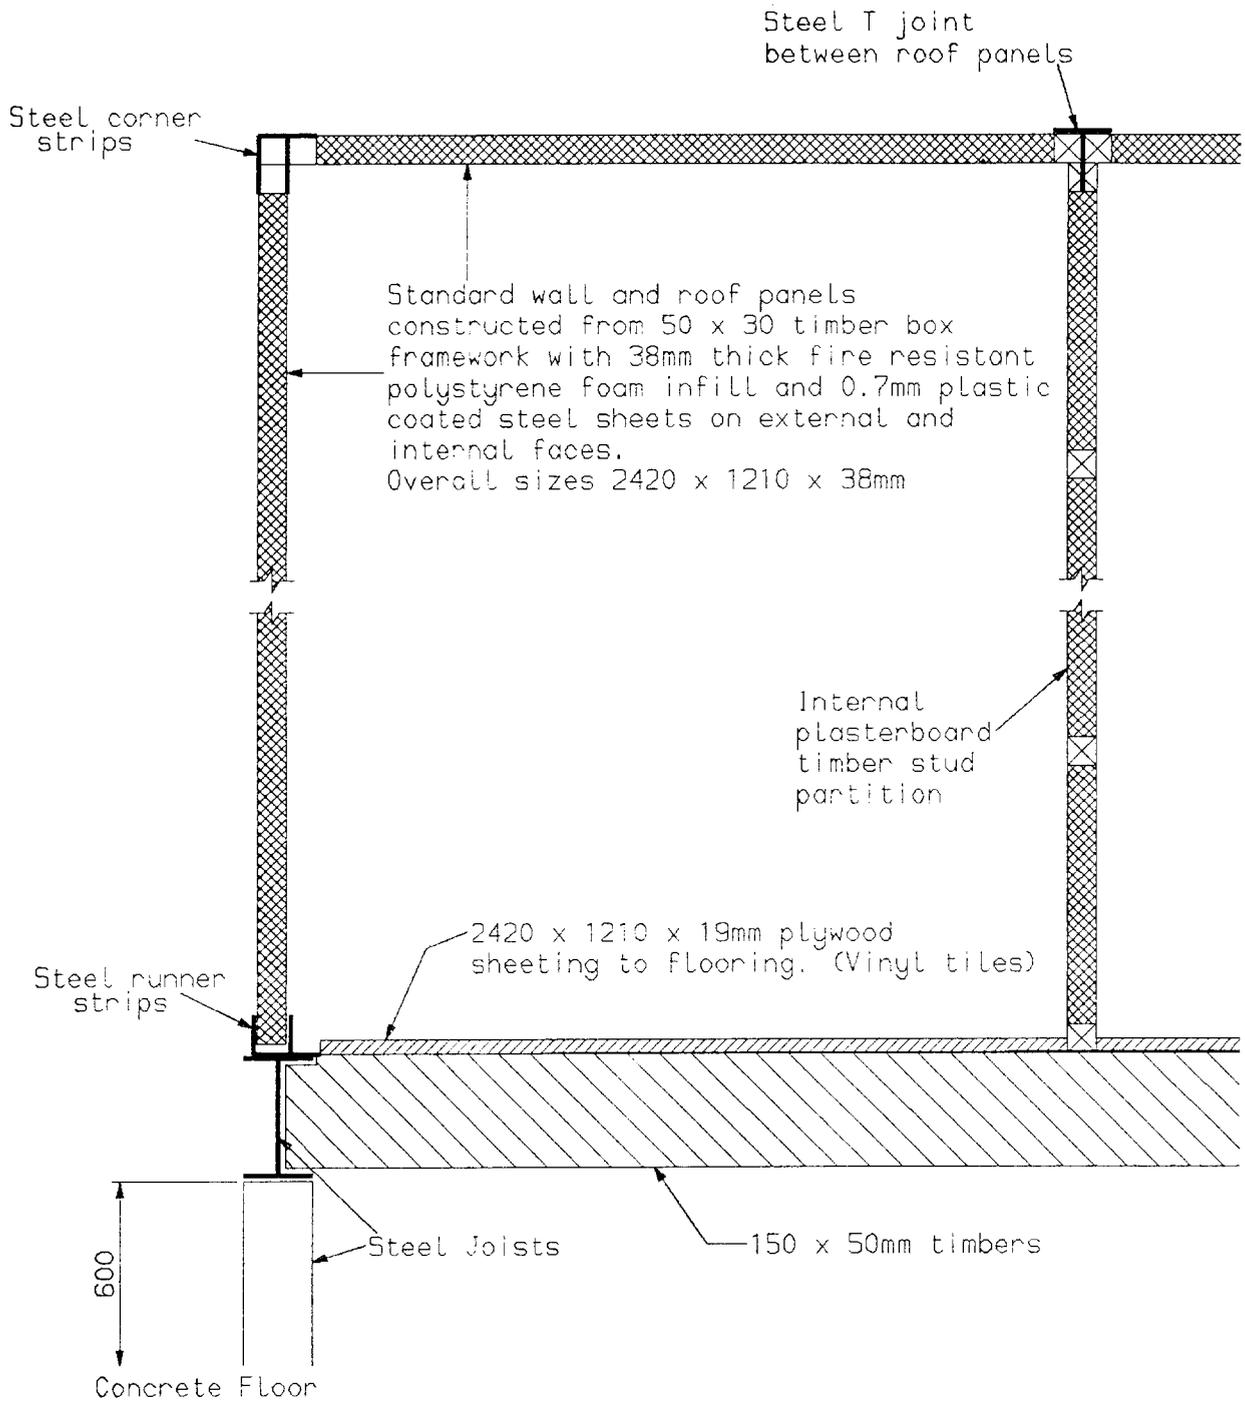
Figure 10: Constructional Details of the Sub Contractors Hut which was destroyed in the fire

A sketch showing the basic construction of the hut is shown in Figure 10 while Figure 2 shows an architectural plan at Level 1 showing the approximate layout and sub-division.

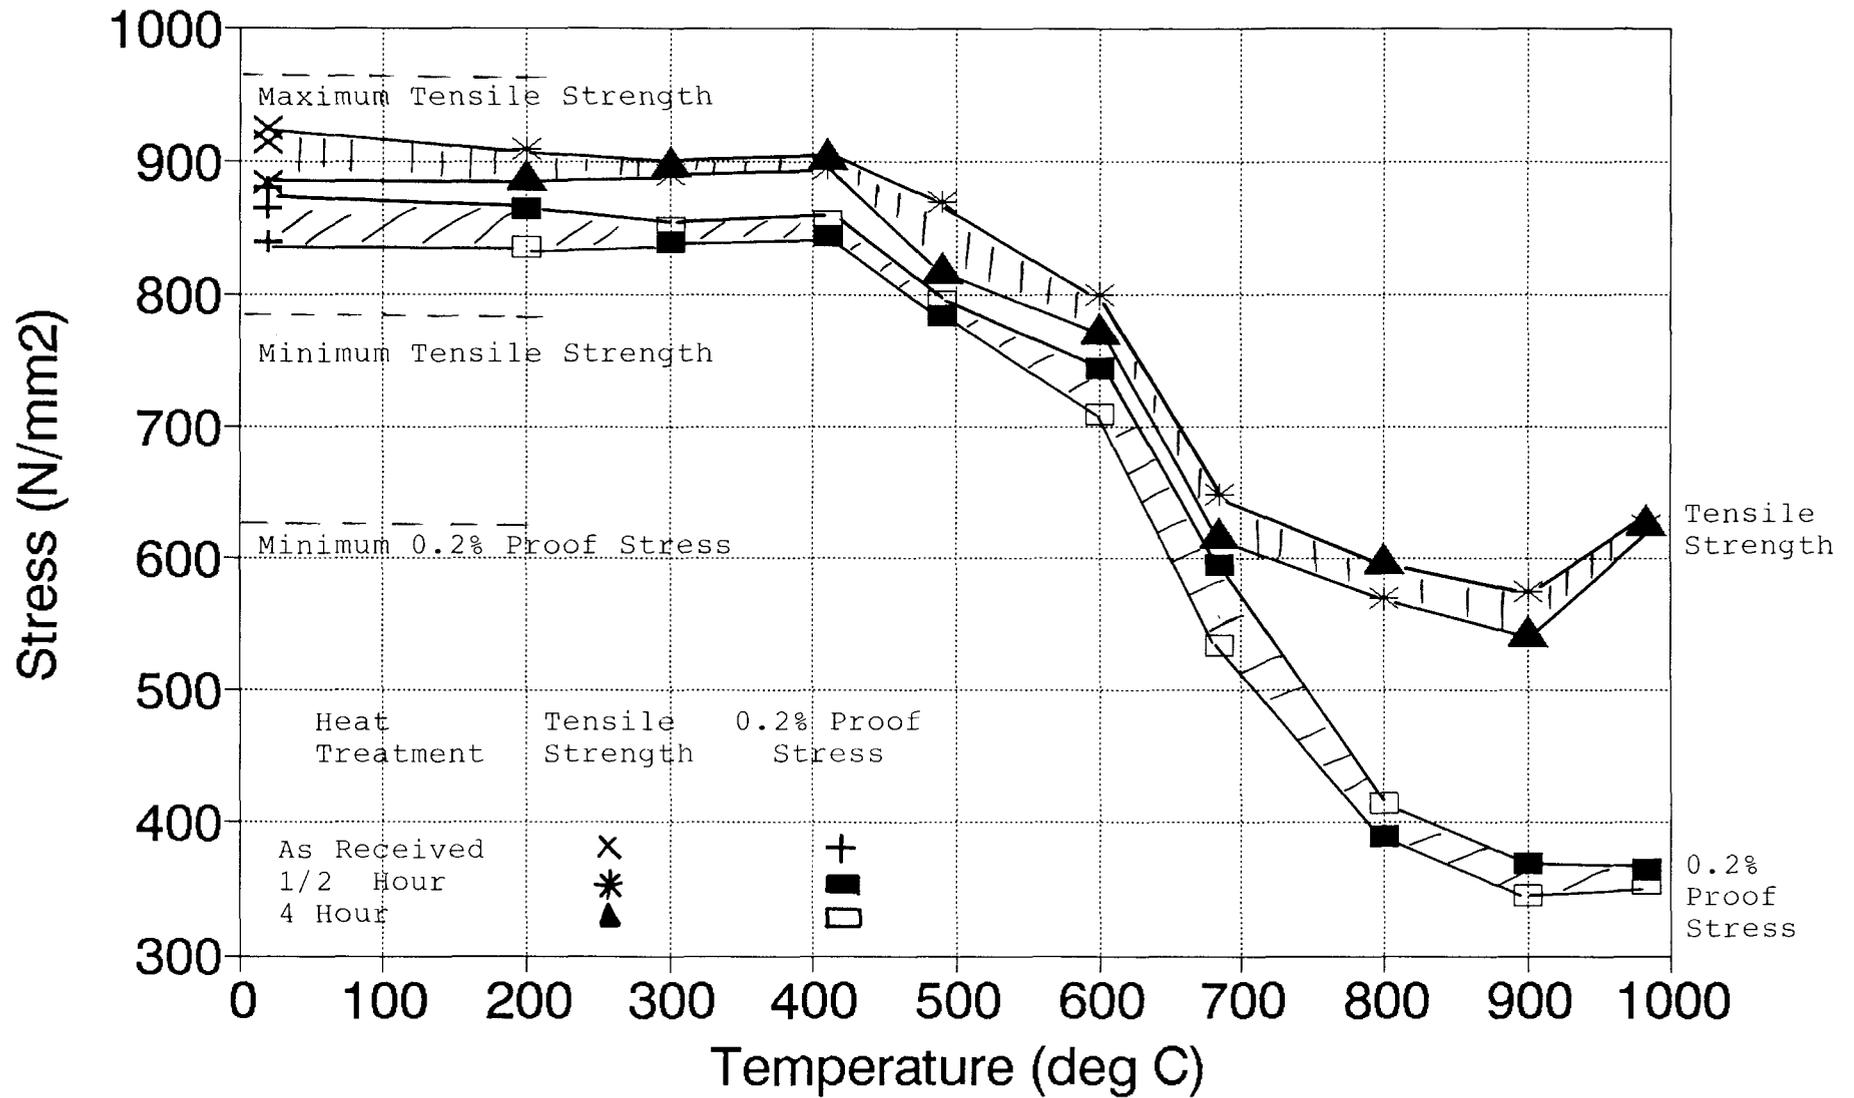
Figure 12: Influence of Fire Simulation Heat Treatment on the Residual Strength of Grade 8.8 Bolts

During their manufacture Grade 8.8 bolts with mechanical properties conforming with BS 3692 are generally oil-quenched from an austenitising temperature of 900°C. The bolts are then tempered in order to establish the required strength and ductility at a temperature in the range 440°C-600°C depending on steel quality. The strength characteristics of bolts are influenced by the heat treatment temperature. Figure 12 shows a plot of strength vs. tempering temperature for Grade 8.8 bolts heat treated for 1/2 hour up to 4 hours. This figure shows that the heat treatment temperature is much more significant than the heat treatment time. The mechanical properties of quenched and tempered steels can also be characterised by their hardness in the Vickers hardness test. The hardness test involves a small scale test which is easily repeated on relatively small specimens. Hardness is related to tensile strength by a relationship presented in ASTM E140 (27).

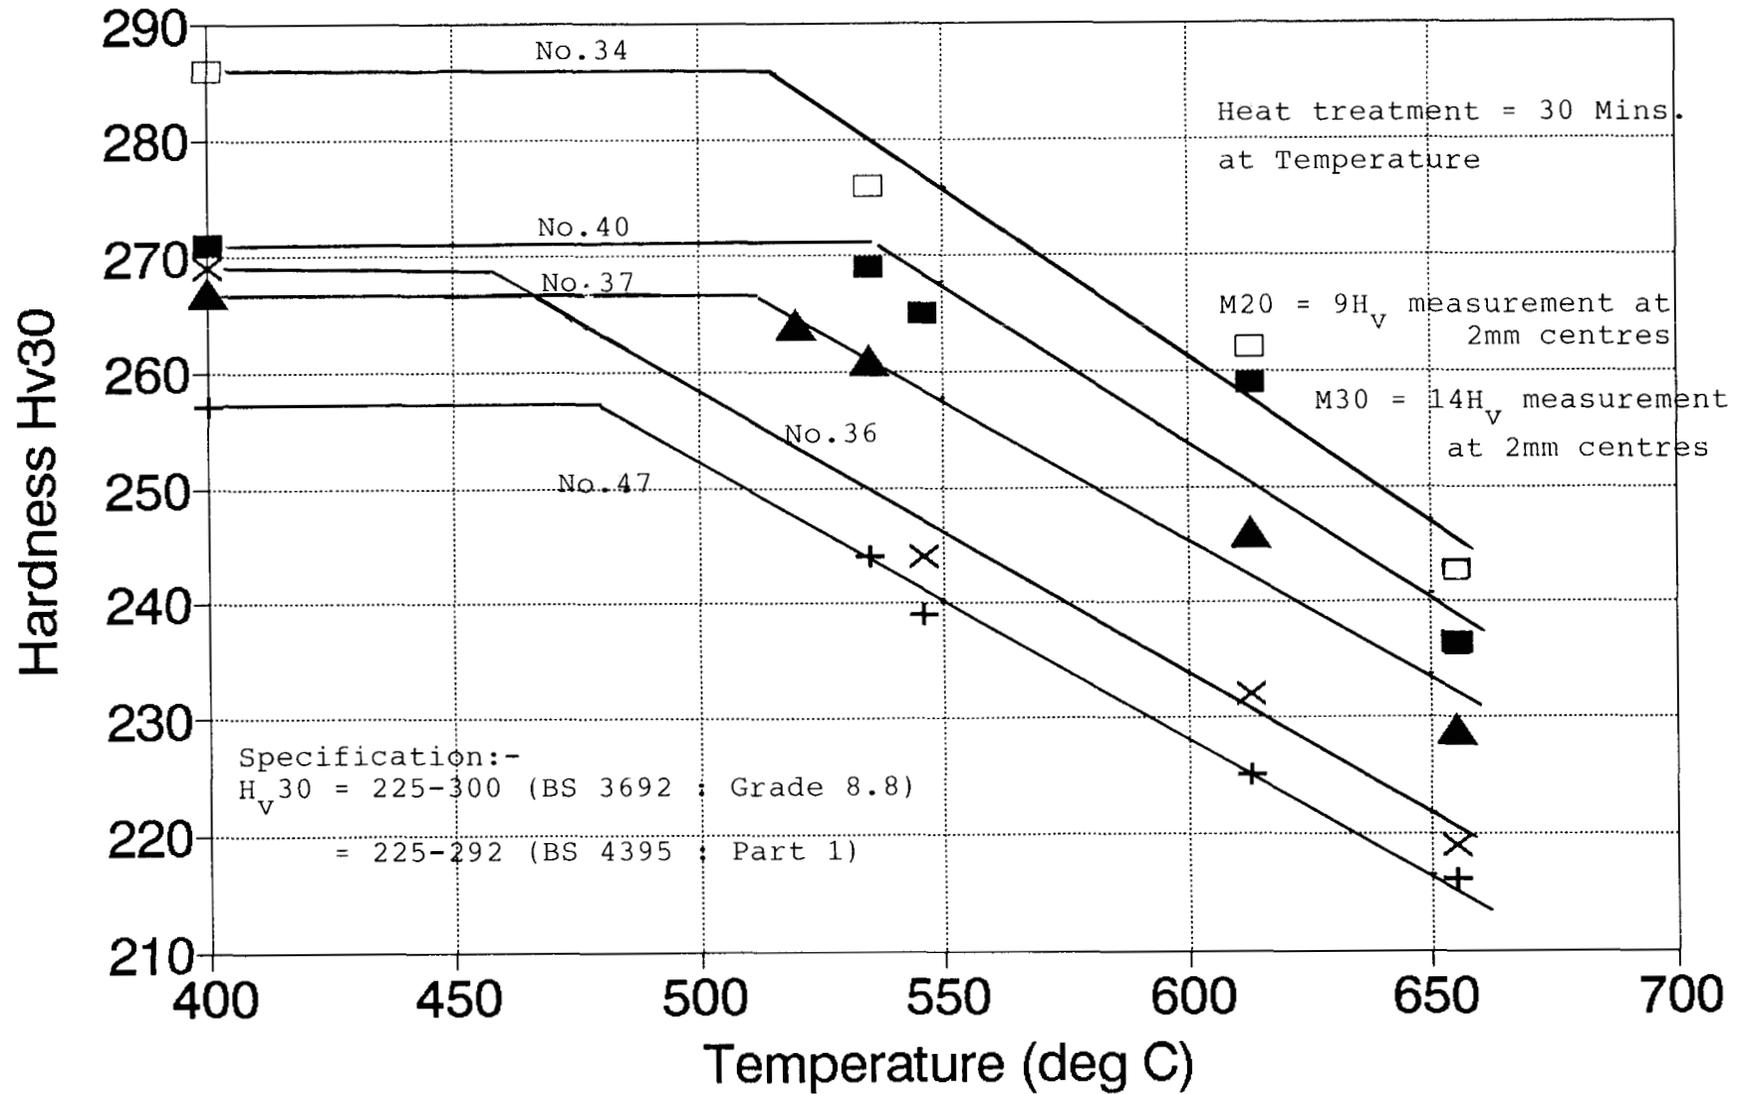
Figure 13: Influence of Tempering Temperature on the Vickers Hardness of Bolts Recovered from the Building

The graphs shown in Figure 13 indicate that the maximum temperatures reached by the bolts were as follows:

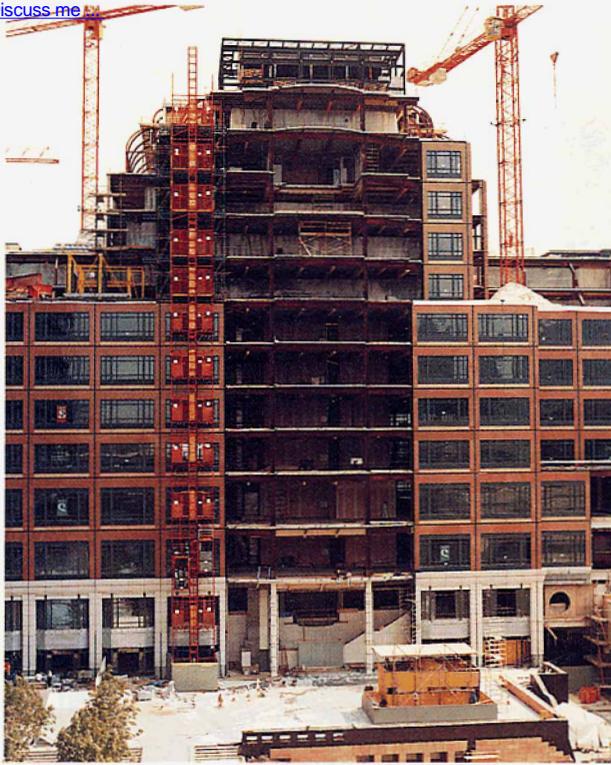
Plate 2 shows a photograph of a similar hut on the floor above after the fire. This hut suffered slight damage as a consequence of fire destroying the windows on both first and second levels.

Plate 1: Broadgate Phase 8 from the Exchange Square showing the overall size of the structure taken prior to the fire.

Plate 2: Photograph of a sub-contractor's hut typical of that which was destroyed during the fire. This hut is located at Level Two and was damaged externally during the fire as a consequence of flames through the windows from the fire at the floor below. Note flaking pvc wall coating.
