Royal Borough gets leisure boost

Structural steelwork, combined with glulam beams, has provided the design solution for a leisure centre stacked with sport and fitness facilities.

Kingston Leisure Centre

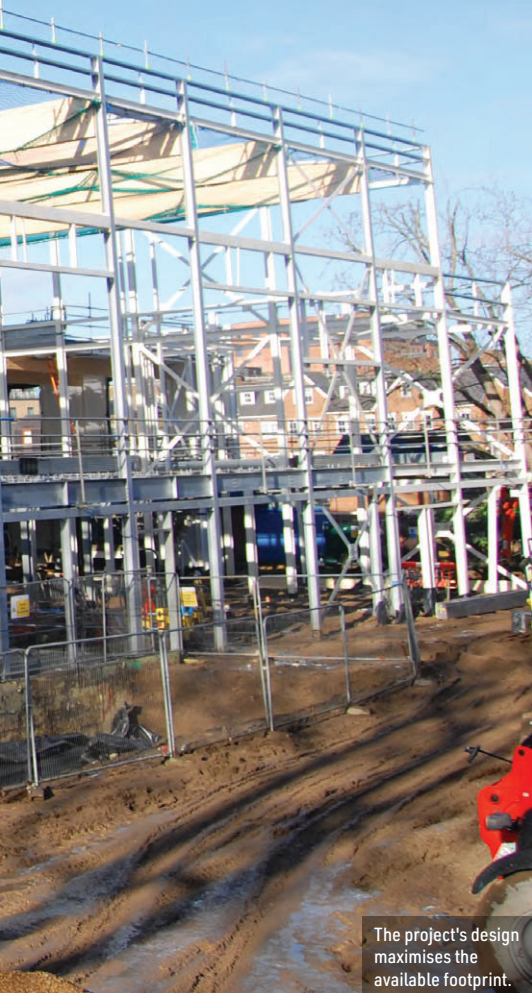
The project's design maximises the available footprint.

The steel frame forms a two-storey structure, with as many different facilities as possible, stacked up within the available footprint.

In this way, the aquatic facilities are on the ground floor, with the majority of the other spaces located at first-floor level.

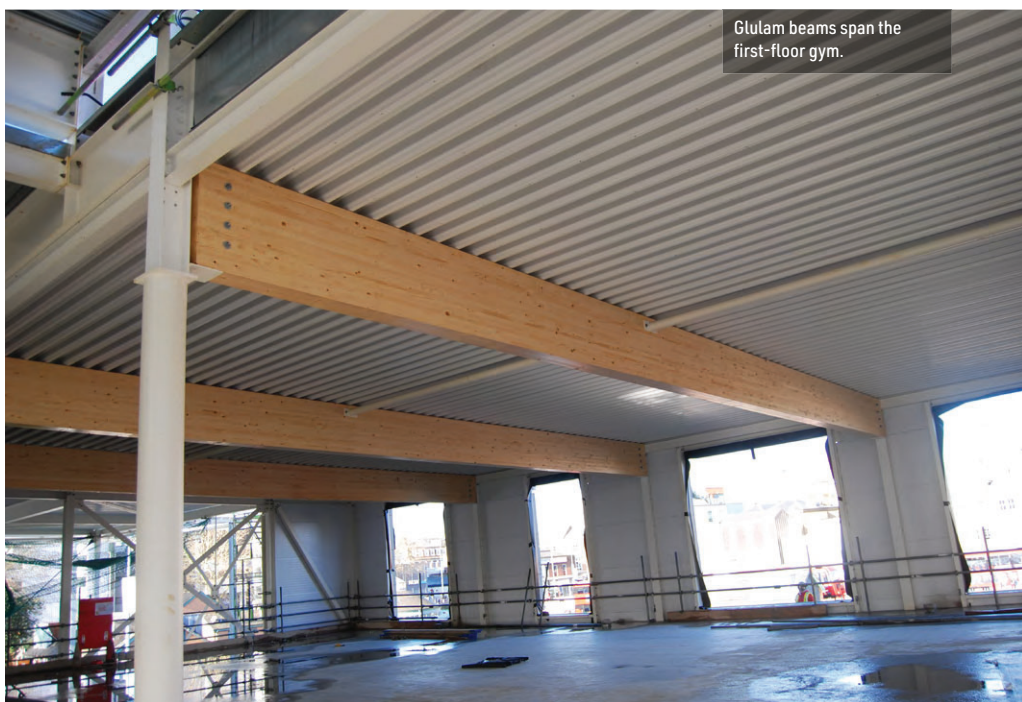
Glulam beams span the first-floor gym.

This double-height space is topped with a series of 20m-long un-spliced glulam beams. Also on this floor, another series of slightly shorter (15m-long) glulams span over the single-storey fitness suite.

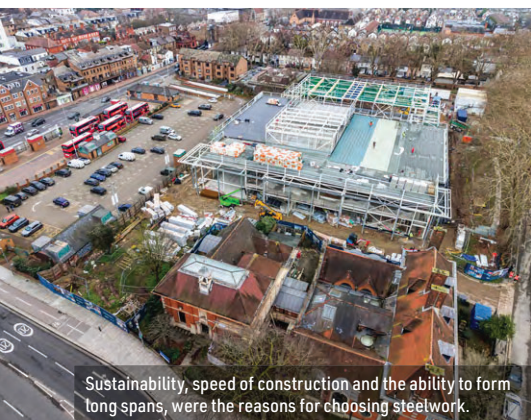
Sustainability, speed of construction and the ability to form long spans, were the reasons for choosing steelwork.

The main contractor for the [steel-framed](#) centre is Pellikaan Construction, a company that specialises in sport and leisure facilities. Its design and build ethos for such projects usually involves the use of steel, in order to achieve the [speed of construction](#) and the long column-free spans leisure and sports clubs require.

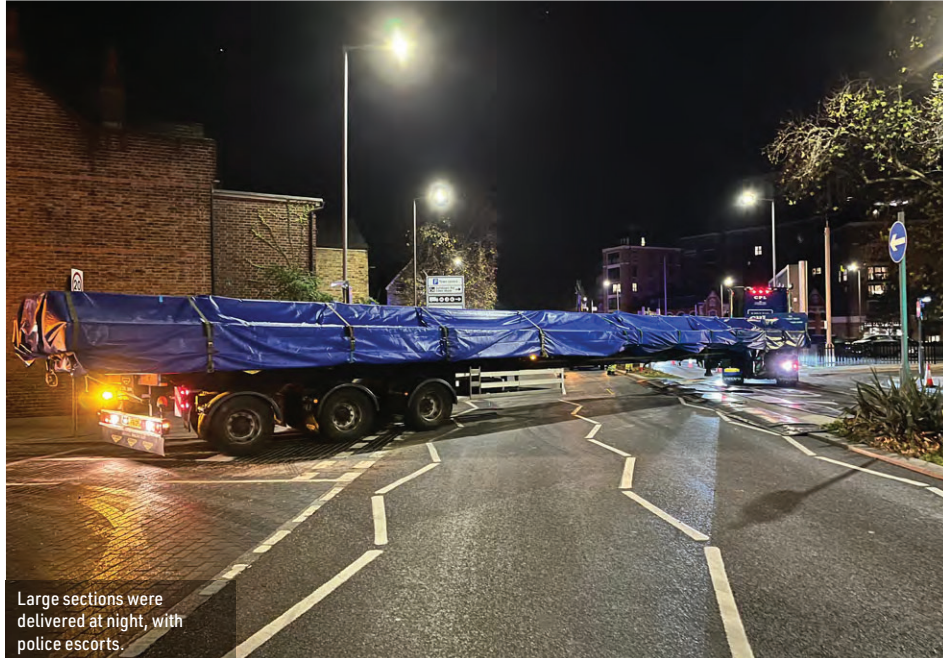
Large sections were delivered at night, with police escorts.

"Sourcing and installing the glulams, each weighing 4.5t, was part of our steelwork package," explains H Young Structures Managing Director Ian Peachment.

"Transported from Austria, they were then delivered to site at night, under police escorts, and with a road closure and traffic management in place, due to their length."
